Access Compliance Report

Public Rights-of-Way

(Curb Ramps)

Intersection ID: 19459	Main Street: ECHODALE_DR	Cross Street: NATIONS_FORD_RD	Location: SW
ADA ID: D7E4AC22677E	Ramp Type: PerpDiag	Initial Pass/Fail: Fail	Overall Compliance: No
		Severity Score: 12.5

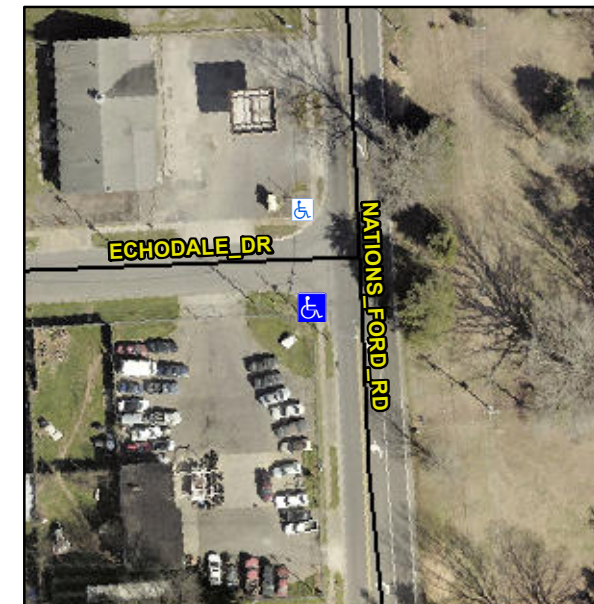
Compliance	Description	Data	Compliance	Description	Data
N/A	Ramp Length (in)	24.0	No	Ramp Slope (%)	8.8
Yes	Ramp Width (in)	48.0	Yes	Ramp XSlope (%)	0.2
N/A	Flare Type LT	N/A	N/A	Flare Type RT	N/A
N/A	Flare Slope LT (%)	N/A	N/A	Flare Slope RT (%)	N/A
N/A	Flare Traversable LT?	N/A	N/A	Flare Traversable RT?	N/A
N/A	Landing Length (in)	N/A	N/A	DWS Provided?	N/A
N/A	Landing Width (in)	N/A	N/A	DWS Contrast?	N/A
N/A	Landing Slope (%)	N/A	N/A	DWS Length (in)	N/A
N/A	Landing X Slope (%)	N/A	N/A	DWS Full Width?	N/A
N/A	Landing Curb? (Y/N)	N/A	N/A	DWS Offset (in)	N/A
N/A	Shared Landing?	N/A			
N/A	Gutter Ponding?	N/A	N/A	Gutter Slope (%)	N/A
N/A	Gutter Lip Ht (in)	N/A	N/A	Gutter X Slope (%)	N/A
N/A	Painted X Walk1?	No	N/A	Painted X Walk2?	No
	X Walk 1 Direction	To E		X Walk 2 Direction	To N
N/A	X Walk 1 Width (in)	N/A	N/A	X Walk 2 Width (in)	N/A
	X Walk 1 Slope (%)	7.3		X Walk 2 Slope (%)	1.2
	X Walk 1 X Slope (%)	3.6		X Walk 2 X Slope (%)	2.3

N/A	Ramp inside XWalk1?	N/A	N/A	Ramp inside XWalk2?	N/A
	Road Slope (%)	1.4	N/A	Clear Space?	N/A
	Road X Slope (%)	5.5	N/A	Clear Space to XWalk (in)	N/A
N/A	Any Obstructions?	N/A	N/A	Storm Grate/Utility Hazard?	N/A
	Obstruction Type			Storm Grate/Utility Type	
		N/A			N/A
			Yes	Surface Condition? (G/P)	Good

Possible Solutions:

Remove & Replace Curb Ramp With Two New Directional Ramps or Equivalent.

R304.2.2
