Access Compliance Report

Public Rights-of-Way

(Curb Ramps)

Intersection ID: 16520	Main Street: ORCHARD_CR	Cross Street: S_TRYON_ST	Location: W
ADA ID: D7E4B06EDDB5	Ramp Type: PerpDiag	Initial Pass/Fail: Fail	Overall Compliance: No
		Severity Score: 72.5

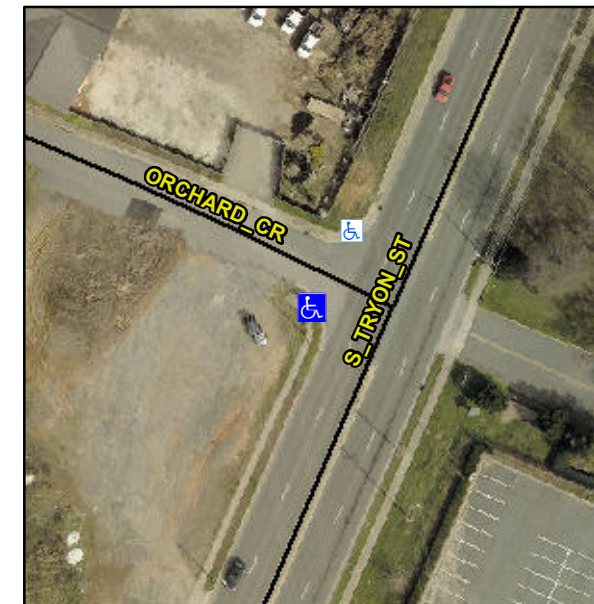
Compliance	Description	Data	Compliance	Description	Data
N/A	Ramp Length (in)	103.0	No	Ramp Slope (%)	9.1
No	Ramp Width (in)	29.0	No	Ramp XSlope (%)	11.4
N/A	Flare Type LT	N/A	N/A	Flare Type RT	N/A
N/A	Flare Slope LT (%)	N/A	N/A	Flare Slope RT (%)	N/A
N/A	Flare Traversable LT?	N/A	N/A	Flare Traversable RT?	N/A
N/A	Landing Length (in)	N/A	N/A	DWS Provided?	N/A
N/A	Landing Width (in)	N/A	N/A	DWS Contrast?	N/A
N/A	Landing Slope (%)	N/A	N/A	DWS Length (in)	N/A
N/A	Landing X Slope (%)	N/A	N/A	DWS Full Width?	N/A
N/A	Landing Curb? (Y/N)	N/A	N/A	DWS Offset (in)	N/A
N/A	Shared Landing?	N/A			
N/A	Gutter Ponding?	N/A	N/A	Gutter Slope (%)	N/A
N/A	Gutter Lip Ht (in)	1.0	N/A	Gutter X Slope (%)	N/A
N/A	Painted X Walk1?	No	N/A	Painted X Walk2?	No
	X Walk 1 Direction	To SE		X Walk 2 Direction	To NE
N/A	X Walk 1 Width (in)	N/A	N/A	X Walk 2 Width (in)	N/A
	X Walk 1 Slope (%)	1.1		X Walk 2 Slope (%)	5.3
	X Walk 1 X Slope (%)	6.7		X Walk 2 X Slope (%)	2.8

N/A	Ramp inside XWalk1?	N/A	N/A	Ramp inside XWalk2?	N/A
	Road Slope (%)	4.1	N/A	Clear Space?	N/A
	Road X Slope (%)	3.9	N/A	Clear Space to XWalk (in)	N/A
N/A	Any Obstructions?	N/A	N/A	Storm Grate/Utility Hazard?	N/A
	Obstruction Type			Storm Grate/Utility Type	
		N/A			N/A
			Yes	Surface Condition? (G/P)	Good

Remove & Replace Curb Ramp With Two New Directional Ramps or Equivalent.

R304.5.1, R304.2.2, R304.5.3
