# Access Compliance Report

## Public Rights-of-Way

### (Curb Ramps)

Intersection ID: 31741	Main Street: LEAF_PLUM_DR	Cross Street: SPIREA_CT	Location: SE
ADA ID: D7EDB6ABDB7B	Ramp Type: PerpDiag	Initial Pass/Fail: Fail	Overall Compliance: No
Codes/Mitigation Info/Possible Solution		Field Measurements/Component Compliance	
Severity Score: 21.25

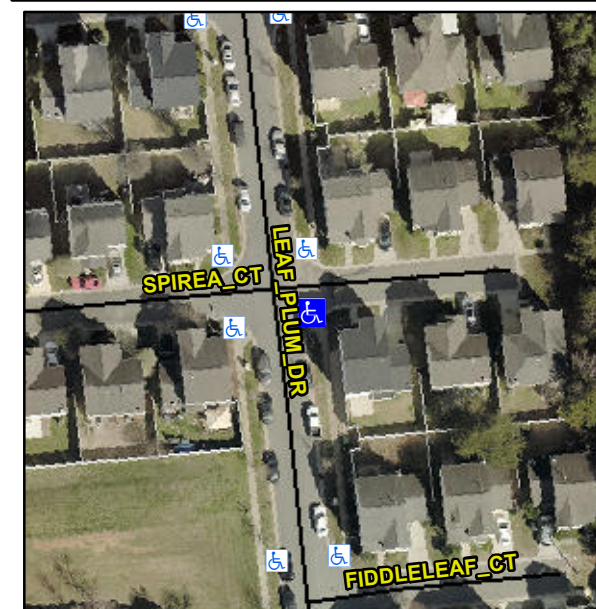
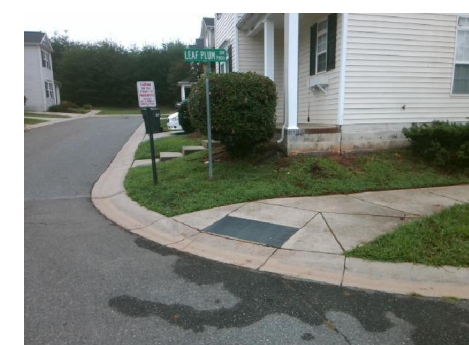
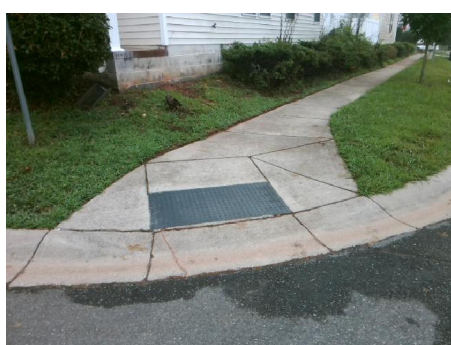
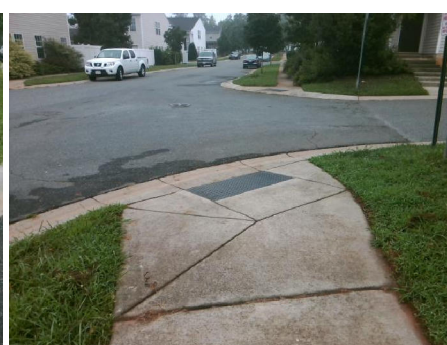
**Not Found, R304.5.1, R304.2.2**

Compliance	Description	Data	Compliance	Description	Data
N/A	Ramp Length (in)	53.0	No	Ramp Slope (%)	9.4
No	Ramp Width (in)	47.5	Yes	Ramp XSlope (%)	1.2
N/A	Flare Type LT	N/A	N/A	Flare Type RT	N/A
N/A	Flare Slope LT (%)	N/A	N/A	Flare Slope RT (%)	N/A
N/A	Flare Traversable LT?	N/A	N/A	Flare Traversable RT?	N/A
N/A	Landing Length (in)	N/A	N/A	DWS Provided?	N/A
N/A	Landing Width (in)	N/A	N/A	DWS Contrast?	N/A
N/A	Landing Slope (%)	N/A	N/A	DWS Length (in)	N/A
N/A	Landing X Slope (%)	N/A	N/A	DWS Full Width?	N/A
N/A	Landing Curb? (Y/N)	N/A	N/A	DWS Offset (in)	N/A
N/A	Shared Landing?	N/A			
N/A	Gutter Ponding?	N/A	N/A	Gutter Slope (%)	N/A
N/A	Gutter Lip Ht (in)	N/A	N/A	Gutter X Slope (%)	N/A
N/A	Painted X Walk1?	No	N/A	Painted X Walk2?	No
	X Walk 1 Direction	To N		X Walk 2 Direction	To W
N/A	X Walk 1 Width (in)	N/A	N/A	X Walk 2 Width (in)	N/A
	X Walk 1 Slope (%)	5.4		X Walk 2 Slope (%)	2.9
	X Walk 1 X Slope (%)	0.8		X Walk 2 X Slope (%)	4.3

N/A	Ramp inside XWalk1?	N/A	N/A	Ramp inside XWalk2?	N/A
	Road Slope (%)	1.9	N/A	Clear Space?	N/A
	Road X Slope (%)	2.1	N/A	Clear Space to XWalk (in)	N/A
N/A	Any Obstructions?	N/A	N/A	Storm Grate/Utility Hazard?	N/A
	Obstruction Type			Storm Grate/Utility Type	
		N/A			N/A
			Yes	Surface Condition? (G/P)	Good

Possible Solutions:

**Remove & Replace Curb Ramp With Two New Directional Ramps or Equivalent.**

Total Cost: \$ 3200.00
