# Access Compliance Report

## Public Rights-of-Way

### (Curb Ramps)

| ADA ID: D7F807C16FFB | Ramp Type: Directional2 | Initial Pass/Fail: Fail | Overall Compliance: No |

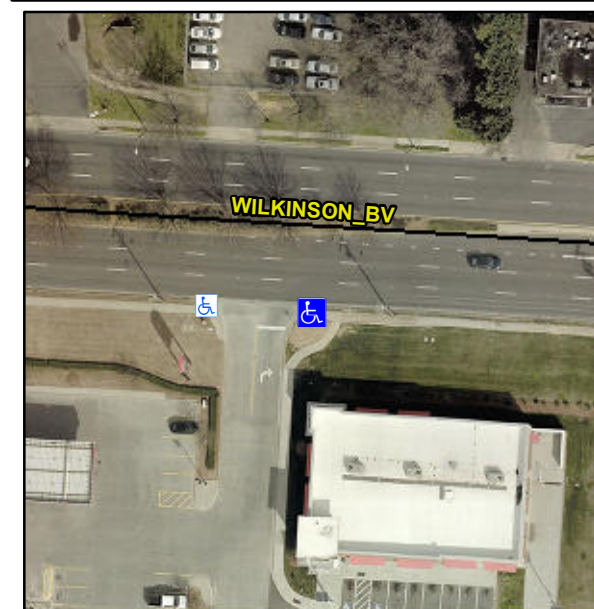
**MEDIAN ACROSS WILKINSON BV**

**R304.2.2**

| Compliance | Description | Data | Compliance | Description | Data |
|---|---|---|---|---|---|
| No | Ramp Slope (%) | 9.1 | N/A | Grade Break XSlope (%) | 0.0 |

**Remove & Replace Entire Ramp.**
