# Access Compliance Report

## Public Rights-of-Way

### (Curb Ramps)

Intersection ID: 18172	Main Street: FOREST_GREEN_DR	Cross Street: LITTLE_MOSER_LN	Location: SW
ADA ID: D7FCFB1DA109	Ramp Type: PerpDiag	Initial Pass/Fail: Fail	Overall Compliance: No
Severity Score: 21.25			
Codes/Mitigation Info/Possible Solution		Field Measurements/Component Compliance

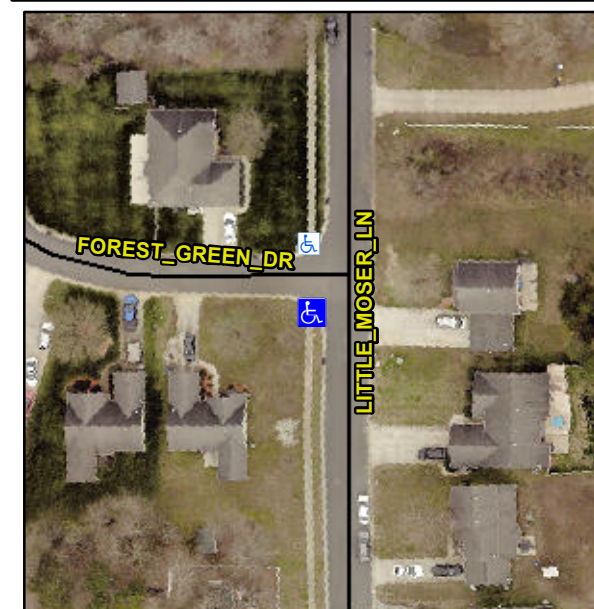
**Not Found, R304.5.1, R304.2.2**

Compliance	Description	Data	Compliance	Description	Data
N/A	Ramp Length (in)	50.0	No	Ramp Slope (%)	8.6
No	Ramp Width (in)	39.0	Yes	Ramp XSlope (%)	0.5
N/A	Flare Type LT	N/A	N/A	Flare Type RT	N/A
N/A	Flare Slope LT (%)	N/A	N/A	Flare Slope RT (%)	N/A
N/A	Flare Traversable LT?	N/A	N/A	Flare Traversable RT?	N/A
N/A	Landing Length (in)	N/A	N/A	DWS Provided?	N/A
N/A	Landing Width (in)	N/A	N/A	DWS Contrast?	N/A
N/A	Landing Slope (%)	N/A	N/A	DWS Length (in)	N/A
N/A	Landing X Slope (%)	N/A	N/A	DWS Full Width?	N/A
N/A	Landing Curb? (Y/N)	N/A	N/A	DWS Offset (in)	N/A
N/A	Shared Landing?	N/A			
N/A	Gutter Ponding?	N/A	N/A	Gutter Slope (%)	N/A
N/A	Gutter Lip Ht (in)	N/A	N/A	Gutter X Slope (%)	N/A
N/A	Painted X Walk1?	No	N/A	Painted X Walk2?	No
	X Walk 1 Direction	To E		X Walk 2 Direction	To N
N/A	X Walk 1 Width (in)	N/A	N/A	X Walk 2 Width (in)	N/A
	X Walk 1 Slope (%)	3.3		X Walk 2 Slope (%)	1.8
	X Walk 1 X Slope (%)	4.5		X Walk 2 X Slope (%)	2.3

N/A	Ramp inside XWalk1?	N/A	N/A	Ramp inside XWalk2?	N/A
	Road Slope (%)	2.1	N/A	Clear Space?	N/A
	Road X Slope (%)	3.0	N/A	Clear Space to XWalk (in)	N/A
N/A	Any Obstructions?	N/A	N/A	Storm Grate/Utility Hazard?	N/A
	Obstruction Type			Storm Grate/Utility Type	
		N/A			N/A
		Yes		Surface Condition? (G/P)	Good

**Remove & Replace Curb Ramp With Two New Directional Ramps or Equivalent.**

Total Cost: \$ 3200.00
