Access Compliance Report Public Rights-of-Way (Curb Ramps)

Intersection ID: 17274 Main Street: MONROE_RD Cross Street: VISTA_DR Location: E

ADA ID: D7FF6AF6FC69 Ramp Type: Directional1 Initial Pass/Fail: Pass Overall Compliance: No Severity Score: 0.25

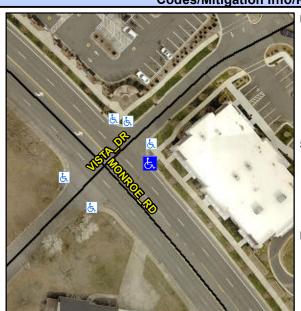
Field Measurements/Component Compliance					
Compliance Description		Data	Compliance Description		Data
N/A	Ramp Length (in)	85.0	Yes	Grade Break?	Yes
Yes	Ramp Width (in)	70.0	Yes	Grade Break Slope (%)	1.6
Yes	Ramp Slope (%)	4.1	Yes	Grade Break XSlope (%)	1.0
No	Ramp XSlope (%)	2.3			
Yes	Flare Type LT	N/A	Yes	Flare Type RT	N/A
N/A	Flare Slope LT (%)	N/A	N/A	Flare Slope RT (%)	N/A
N/A	Flare Traversable LT?	No	N/A	Flare Traversable RT?	No
Yes	Landing Length (in)	70.0	Yes	DWS Provided?	Yes
Yes	Landing Width (in)	70.0	Yes	DWS Contrast?	Yes
Yes	Landing Slope (%)	0.0	Yes	DWS Length (in)	24.0
Yes	Landing X Slope (%)	1.8	Yes	DWS Full Width?	Yes
N/A	Landing Curb? (Y/N)	No	Yes	DWS Offset LT (in)	0.0
N/A	Shared Landing?	No	Yes	DWS Offset RT (in)	8.0
Yes	Gutter Ponding?	No	Yes	Gutter Slope (%)	0.7
Yes	Gutter Lip Ht (in)	0.0	Yes	Gutter X Slope (%)	1.1
N/A	Painted X Walk1?	No		Road Slope (%)	0.6
	X Walk 1 Direction	To SW		Road X Slope (%)	1.3

X Walk 1 Width (in)	N/A	l	Clear Space?	Yes
	X Walk 1 Slope (%)	0.6	N/A	Clear Space to XWalk (in)	N/A
	X Walk 1 X Slope (%)	1.3	Yes	Storm Grate/Utility Hazard?	No
N/A	Ramp inside XWalk1?	N/A		Storm Grate/Utility Type	
Yes	Any Obstructions?	No			N/A
	Obstruction Type		Yes	Surface Condition? (G/P)	Good
		N/A	N/A	Curb Slope (%)	7.6

Possible Solutions:

Remove & Replace Entire Ramp.

R304.5.3
