Access Compliance Report

Public Rights-of-Way

(Curb Ramps)

| Intersection ID: 10276 | Main Street: ASHLEY_RD | Cross Street: TUCKASEEGEE_RD | Location: NW |

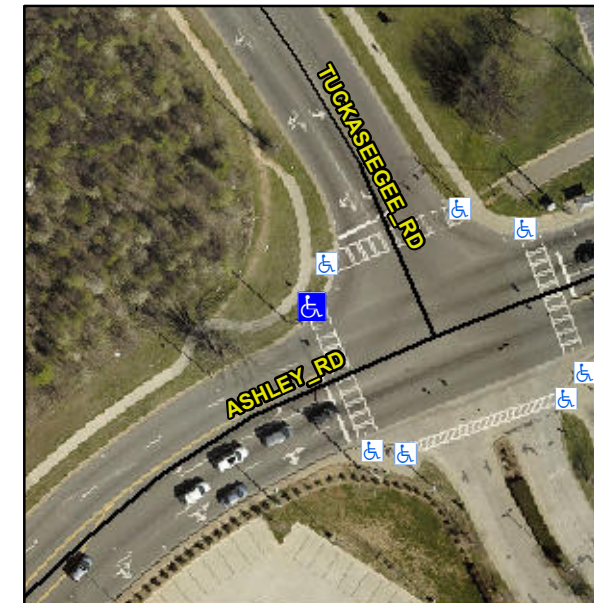
Not Found, R304.5.1, R304.5.3

| Compliance | Description | Data | Compliance | Description | Data |
|---|---|---|---|---|---|
| N/A | Ramp Length (in) | 98.0 | Yes | Ramp Slope (%) | 7.3 |
| No | Ramp Width (in) | 47.0 | No | Ramp XSlope (%) | 3.5 |

Remove & Replace Entire Ramp.
