Access Compliance Report

Public Rights-of-Way

(Curb Ramps)

Intersection ID: 47272	Main Street: LEAHURST_CT	Cross Street: LIDDINGTON_RD	Location: NW
ADA ID: D80887411712	Ramp Type: Perp	Initial Pass/Fail: Fail	Overall Compliance: No
Severity Score: 10			
Codes/Mitigation Info/Possible Solution		Field Measurements/Component Compliance

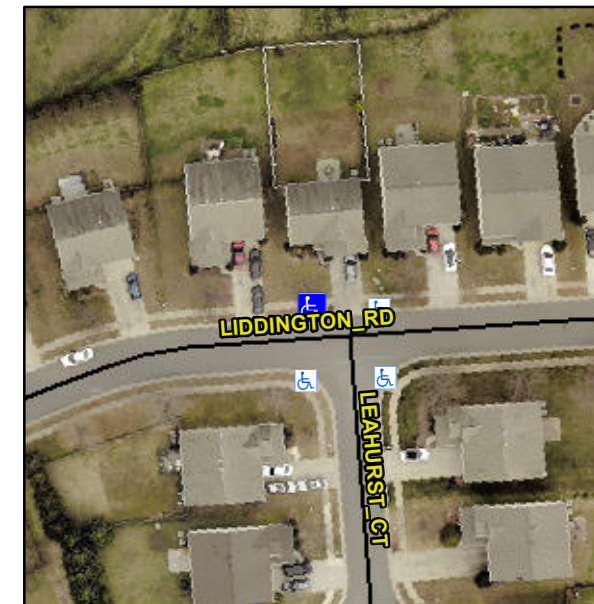
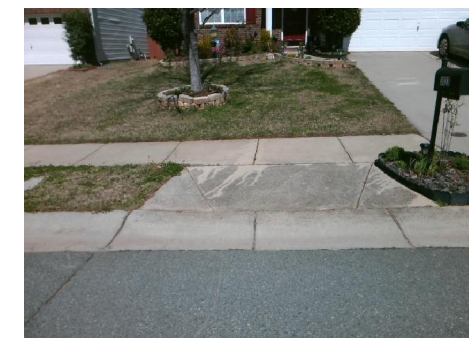
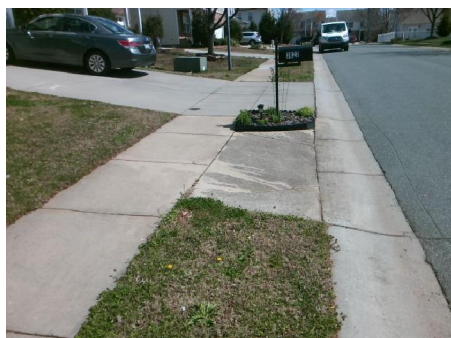
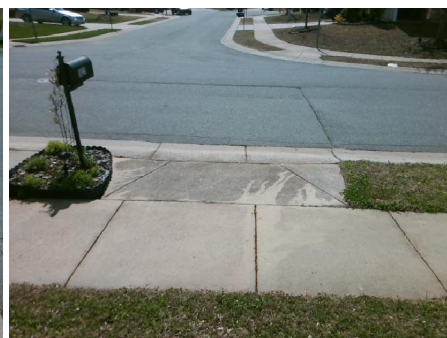
Not Found, R304.5.1

Compliance	Description	Data	Compliance	Description	Data
N/A	Ramp Length (in)	47.5	Yes	Ramp Slope (%)	7.6
No	Ramp Width (in)	47.0	Yes	Ramp XSlope (%)	2.8
N/A	Flare Type LT	N/A	N/A	Flare Type RT	N/A
N/A	Flare Slope LT (%)	N/A	N/A	Flare Slope RT (%)	N/A
N/A	Flare Traversable LT?	N/A	N/A	Flare Traversable RT?	N/A
N/A	Landing Length (in)	N/A	N/A	DWS Provided?	N/A
N/A	Landing Width (in)	N/A	N/A	DWS Contrast?	N/A
N/A	Landing Slope (%)	N/A	N/A	DWS Length (in)	N/A
N/A	Landing X Slope (%)	N/A	N/A	DWS Full Width?	N/A
N/A	Landing Curb? (Y/N)	N/A	N/A	DWS Offset (in)	N/A
N/A	Shared Landing?	N/A			
N/A	Gutter Ponding?	N/A	N/A	Gutter Slope (%)	N/A
N/A	Gutter Lip Ht (in)	N/A	N/A	Gutter X Slope (%)	N/A
N/A	Painted X Walk1?	No	N/A	Painted X Walk2?	N/A
	X Walk 1 Direction	To S		X Walk 2 Direction	N/A
N/A	X Walk 1 Width (in)	N/A	N/A	X Walk 2 Width (in)	N/A
	X Walk 1 Slope (%)	3.9		X Walk 2 Slope (%)	N/A
	X Walk 1 X Slope (%)	2.8		X Walk 2 X Slope (%)	N/A

N/A	Ramp inside XWalk1?	N/A	N/A	Ramp inside XWalk2?	N/A
	Road Slope (%)	N/A	N/A	Clear Space?	N/A
	Road X Slope (%)	N/A	N/A	Clear Space to XWalk (in)	N/A
N/A	Any Obstructions?	N/A	N/A	Storm Grate/Utility Hazard?	N/A
	Obstruction Type			Storm Grate/Utility Type	
		N/A			N/A
			Yes	Surface Condition? (G/P)	Good

Possible Solutions:

Remove & Replace Entire Ramp.
