Access Compliance Report

Public Rights-of-Way

(Curb Ramps)

Intersection ID: 9278	Main Street: OAKLAWN_AV	Cross Street: BOOKER_AV	Location: W
ADA ID: D80CEAAD4D00	Ramp Type: Perp	Initial Pass/Fail: Fail	Overall Compliance: No
Severity Score: 31.25			
Codes/Mitigation Info/Possible Solution		Field Measurements/Component Compliance

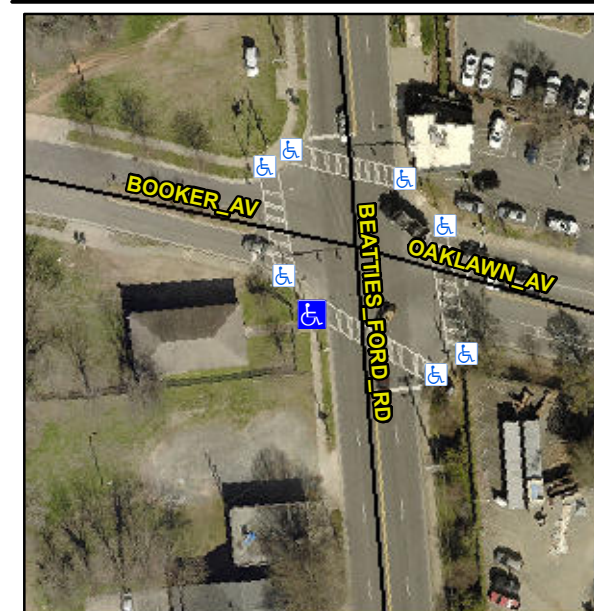
Not Found, R304.5.1, R304.2.2

Compliance	Description	Data	Compliance	Description	Data
N/A	Ramp Length (in)	55.5	No	Ramp Slope (%)	11.5
No	Ramp Width (in)	35.0	Yes	Ramp XSlope (%)	3.0
N/A	Flare Type LT	N/A	N/A	Flare Type RT	N/A
N/A	Flare Slope LT (%)	N/A	N/A	Flare Slope RT (%)	N/A
N/A	Flare Traversable LT?	N/A	N/A	Flare Traversable RT?	N/A
N/A	Landing Length (in)	N/A	N/A	DWS Provided?	N/A
N/A	Landing Width (in)	N/A	N/A	DWS Contrast?	N/A
N/A	Landing Slope (%)	N/A	N/A	DWS Length (in)	N/A
N/A	Landing X Slope (%)	N/A	N/A	DWS Full Width?	N/A
N/A	Landing Curb? (Y/N)	N/A	N/A	DWS Offset (in)	N/A
N/A	Shared Landing?	N/A			
N/A	Gutter Ponding?	N/A	N/A	Gutter Slope (%)	N/A
N/A	Gutter Lip Ht (in)	N/A	N/A	Gutter X Slope (%)	N/A
N/A	Painted X Walk1?	Yes	N/A	Painted X Walk2?	N/A
	X Walk 1 Direction	To SE		X Walk 2 Direction	N/A
N/A	X Walk 1 Width (in)	114.0	N/A	X Walk 2 Width (in)	N/A
	X Walk 1 Slope (%)	3.9		X Walk 2 Slope (%)	N/A
	X Walk 1 X Slope (%)	3.6		X Walk 2 X Slope (%)	N/A

Remove & Replace Entire Ramp.

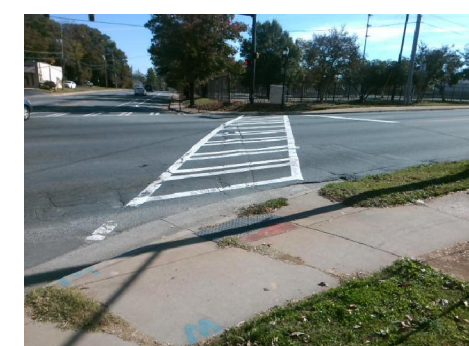
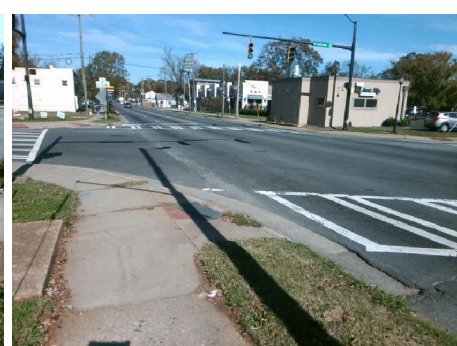
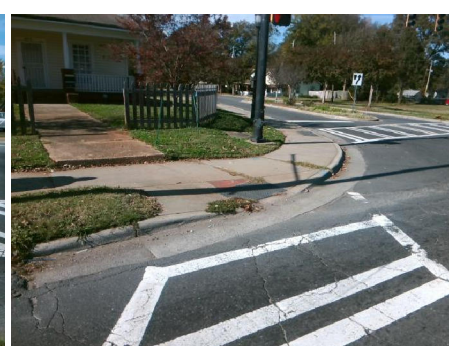
N/A	Ramp inside XWalk1?	Yes	N/A	Ramp inside XWalk2?	N/A
	Road Slope (%)	N/A	N/A	Clear Space?	N/A
	Road X Slope (%)	N/A	N/A	Clear Space to XWalk (in)	N/A
N/A	Any Obstructions?	N/A	N/A	Storm Grate/Utility Hazard?	N/A
	Obstruction Type			Storm Grate/Utility Type	
		N/A			N/A
			Yes	Surface Condition? (G/P)	Good
