# Access Compliance Report

## Public Rights-of-Way

### (Curb Ramps)

Intersection ID: 4068	Main Street: FOGGY_BANK_LN	Cross Street: MT_ISLE_HARBOR_DR	Location: SE
ADA ID: D816631ADE8B	Ramp Type: BlendTrans2	Initial Pass/Fail: Fail	Overall Compliance: No
Severity Score: 10			
Codes/Mitigation Info/Possible Solution		Field Measurements/Component Compliance

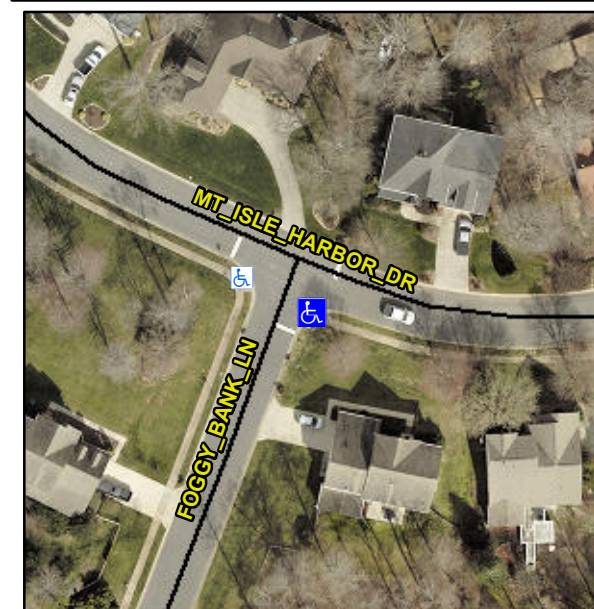
Compliance	Description	Data	Compliance	Description	Data
N/A	Ramp Length (in)	42.0	Yes	BlendTrans Slope (%)	2.6
No	Ramp Width (in)	46.0	No	BlendTrans XSlope (%)	4.5
N/A	Flare Type LT	N/A	N/A	Flare Type RT	N/A
N/A	Flare Slope LT (%)	N/A	N/A	Flare Slope RT (%)	N/A
N/A	Flare Traversable LT?	N/A	N/A	Flare Traversable RT?	N/A
N/A	Landing Length (in)	N/A	N/A	DWS Provided?	N/A
N/A	Landing Width (in)	N/A	N/A	DWS Contrast?	N/A
N/A	Landing Slope (%)	N/A	N/A	DWS Length (in)	N/A
N/A	Landing X Slope (%)	N/A	N/A	DWS Full Width?	N/A
N/A	Landing Curb? (Y/N)	N/A	N/A	DWS Offset (in)	N/A
N/A	Shared Landing?	N/A			
N/A	Gutter Ponding?	N/A	N/A	Gutter Slope (%)	N/A
N/A	Gutter Lip Ht (in)	N/A	N/A	Gutter X Slope (%)	N/A
N/A	Painted X Walk1?	No	N/A	Painted X Walk2?	N/A
	X Walk 1 Direction	To W		X Walk 2 Direction	N/A
	X Walk 1 Width (in)	N/A		X Walk 2 Width (in)	N/A
	X Walk 1 Slope (%)	2.4		X Walk 2 Slope (%)	N/A
	X Walk 1 X Slope (%)	2.5		X Walk 2 X Slope (%)	N/A

N/A	Ramp inside XWalk1?	N/A	N/A	Ramp inside XWalk2?	N/A
	Road Slope (%)	2.5		Clear Space?	N/A
	Road X Slope (%)	2.4	N/A	Clear Space to XWalk (in)	N/A
N/A	Any Obstructions?	N/A	N/A	Storm Grate/Utility Hazard?	N/A
	Obstruction Type			Storm Grate/Utility Type	
		N/A			N/A
			Yes	Surface Condition? (G/P)	Good
			No	Curb Slope (%)	8.2

**Remove & Replace Curb Ramp With Two New Directional Ramps or Equivalent.**
