# Access Compliance Report

## Public Rights-of-Way

### (Curb Ramps)

Intersection ID: 47886	Main Street: BERKELEY PARK CT	Cross Street: PROVIDENCE RD	Location: NW
ADA ID: D81911DEDD1F	Ramp Type: Para	Initial Pass/Fail: Fail	Overall Compliance: No
Codes/Mitigation Info/Possible Solution		Field Measurements/Component Compliance	
Severity Score: 13.75

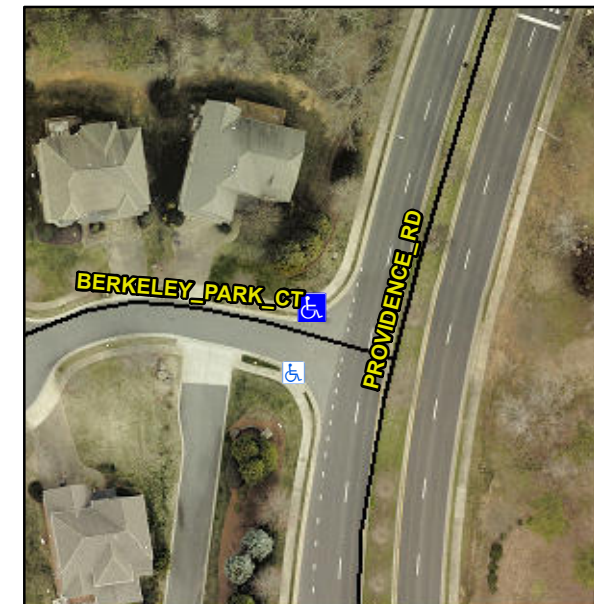
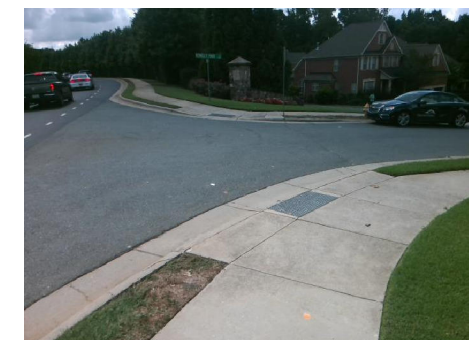
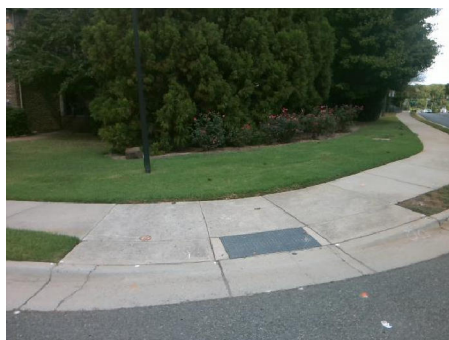
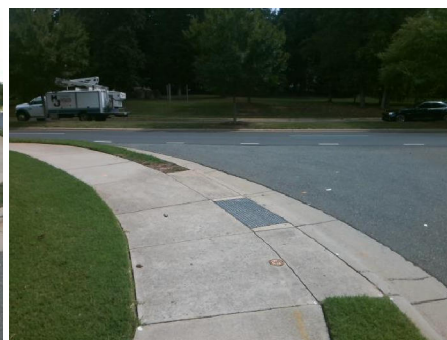
**LT RP < 5%**

Compliance	Description	Data	Compliance	Description	Data
N/A	Ramp Length LT (in)	55.0	N/A	Ramp Length RT (in)	56.0
Yes	Ramp Width LT (in)	59.5	Yes	Ramp Width RT (in)	58.5
Yes	Ramp Slope LT (%)	2.4	No	Ramp Slope RT (%)	10.0
No	Ramp XSlope LT (%)	3.6	Yes	Ramp XSlope RT (%)	0.4
N/A	Landing Length (in)	N/A	N/A	DWS Provided?	N/A
N/A	Landing Width (in)	N/A	N/A	DWS Contrast?	N/A
N/A	Landing Slope (%)	N/A	N/A	DWS Length (in)	N/A
N/A	Landing X Slope (%)	N/A	N/A	DWS Full Width?	N/A
N/A	Landing Curb? (Y/N)	N/A	N/A	DWS Offset (in)	N/A
N/A	Shared Landing?	N/A			
N/A	Gutter Ponding?	N/A	N/A	Gutter Slope (%)	N/A
N/A	Gutter Lip Ht (in)	N/A	N/A	Gutter X Slope (%)	N/A
N/A	Painted X Walk1?	No	N/A	Painted X Walk2?	N/A
	X Walk 1 Direction	To SW		X Walk 2 Direction	N/A
N/A	X Walk 1 Width (in)	N/A	N/A	X Walk 2 Width (in)	N/A
	X Walk 1 Slope (%)	2.0		X Walk 2 Slope (%)	N/A
	X Walk 1 X Slope (%)	4.8		X Walk 2 X Slope (%)	N/A
N/A	Ramp inside XWalk1?	N/A	N/A	Ramp inside XWalk2?	N/A

Road Slope (%)	N/A	N/A	Clear Space?	N/A
	Road X Slope (%)	N/A	N/A	Clear Space to XWalk (in)	N/A
N/A	Any Obstructions?	N/A	N/A	Storm Grate/Utility Hazard?	N/A
	Obstruction Type			Storm Grate/Utility Type	
		N/A			N/A
			Yes	Surface Condition? (G/P)	Good
			N/A	Curb Slope (%)	8.8

**Remove & Replace Entire Ramp.**
