## Access Compliance Report Public Rights-of-Way (Curb Ramps)

Intersection ID: 12613 Main Street: E\_TRADE\_ST Cross Street: S\_BREVARD\_ST Location: W

ADA ID: D82131217503 Ramp Type: PerpDiag Initial Pass/Fail: Fail Overall Compliance: No Severity Score: 13.75

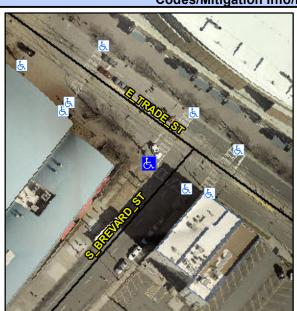
SLOPES VERIFIED & MATCH

R304.2.2, R304.5.3

Compliance Description Data		Data	Comp	liance	Description	Data
N/A	Ramp Length (in)	44.0	No	Ramp	Slope (%)	8.4
Yes	Ramp Width (in)	48.0	No	Ramp	XSlope (%)	3.6
N/A	Flare Type LT	N/A	N/A	Flare	Type RT	N/A
N/A	Flare Slope LT (%)	N/A	N/A	Flare	Slope RT (%)	N/A
N/A	Flare Traversable LT?	N/A	N/A	Flare	Traversable RT?	N/A
N/A	Landing Length (in)	N/A	N/A	DWS	Provided?	N/A
N/A	Landing Width (in)	N/A	N/A	DWS	Contrast?	N/A
N/A	Landing Slope (%)	N/A	N/A	DWS	Length (in)	N/A
N/A	Landing X Slope (%)	N/A	N/A	DWS	Full Width?	N/A
N/A	Landing Curb? (Y/N)	N/A	N/A	DWS	Offset (in)	N/A
N/A	Shared Landing?	N/A				
N/A	Gutter Ponding?	N/A	N/A	Gutte	r Slope (%)	N/A
N/A	Gutter Lip Ht (in)	N/A	N/A	Gutte	r X Slope (%)	N/A
N/A	Painted X Walk1?	Yes	N/A	Paint	ed X Walk2?	Yes
	X Walk 1 Direction	To SW		X Wa	lk 2 Direction	To NW
N/A	X Walk 1 Width (in)	110.0	N/A	X Wa	lk 2 Width (in)	111.0
	X Walk 1 Slope (%)	2.1		X Wa	lk 2 Slope (%)	2.4
	X Walk 1 X Slope (%)	2.2		X Wa	lk 2 X Slope (%)	0.5

N/A	Ramp inside XWalk1?	Yes	N/A	Ramp	inside XWalk2?	Yes
	Road Slope (%)	2.4	N/A	Clear	Space?	N/A
	Road X Slope (%)	1.5	N/A	Clear	Space to XWalk (in)	N/A
N/A	Any Obstructions?	N/A	N/A	Storm	Grate/Utility Hazard?	N/A
	Obstruction Type			Storm	n Grate/Utility Type	
		N/A				N/A

Remove & Replace Curb Ramp With Two New Directional Ramps or Equivalent.
