Access Compliance Report

Public Rights-of-Way

(Curb Ramps)

Intersection ID: 43221	Main Street: HARTFORD_AV	Cross Street: SCALEYBARK_RD	Location: S
ADA ID: D82871A9D76B	Ramp Type: Directional1	Initial Pass/Fail: Fail	Overall Compliance: No
Codes/Mitigation Info/Possible Solution		Field Measurements/Component Compliance	
Severity Score: 1.25

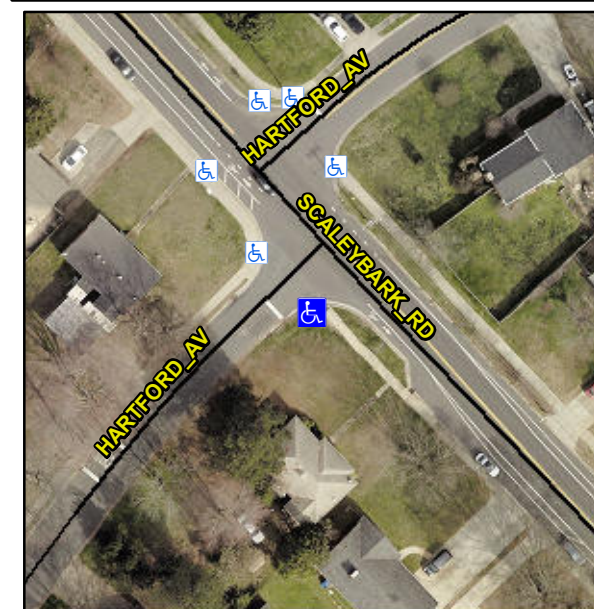
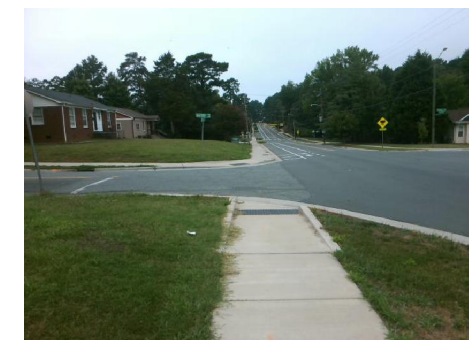
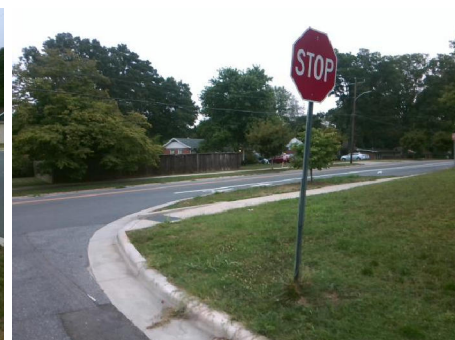
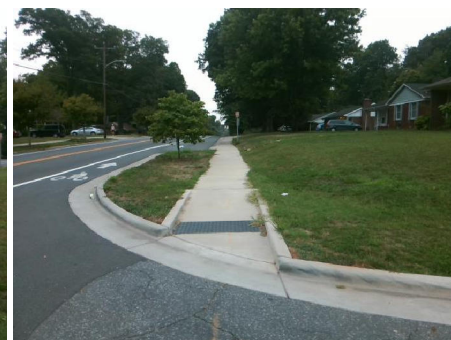
Compliance	Description	Data	Compliance	Description	Data
N/A	Ramp Length (in)	129.0	N/A	Grade Break?	N/A
Yes	Ramp Width (in)	59.0	N/A	Grade Break Slope (%)	0.0
Yes	Ramp Slope (%)	8.1	N/A	Grade Break XSlope (%)	0.0
No	Ramp XSlope (%)	2.3			
N/A	Flare Type LT	N/A	N/A	Flare Type RT	N/A
N/A	Flare Slope LT (%)	N/A	N/A	Flare Slope RT (%)	0.0
N/A	Flare Traversable LT?	N/A	N/A	Flare Traversable RT?	N/A
N/A	Landing Length (in)	0.0	N/A	DWS Provided?	N/A
N/A	Landing Width (in)	0.0	N/A	DWS Contrast?	N/A
N/A	Landing Slope (%)	0.0	N/A	DWS Length (in)	N/A
N/A	Landing X Slope (%)	0.0	N/A	DWS Full Width?	N/A
N/A	Landing Curb? (Y/N)	N/A	N/A	DWS Offset LT (in)	N/A
N/A	Shared Landing?	N/A	N/A	DWS Offset RT (in)	N/A
N/A	Gutter Ponding?	0.0	N/A	Gutter Slope (%)	N/A
N/A	Gutter Lip Ht (in)	0.0	N/A	Gutter X Slope (%)	N/A
N/A	Painted X Walk1?	No		Road Slope (%)	2.9
	X Walk 1 Direction	To NW		Road X Slope (%)	1.4
	X Walk 1 Width (in)	N/A		Clear Space?	N/A

X Walk 1 Slope (%)	2.9	N/A	Clear Space to XWalk (in)	N/A
	X Walk 1 X Slope (%)	1.4	N/A	Storm Grate/Utility Hazard?	N/A
N/A	Ramp inside XWalk1?	N/A		Storm Grate/Utility Type	
N/A	Any Obstructions?	N/A			N/A
	Obstruction Type		Yes	Surface Condition? (G/P)	Good
			N/A	Curb Slope (%)	7.2

Possible Solutions:

Remove & Replace Entire Ramp.

R304.5.3
