Access Compliance Report

Public Rights-of-Way

Intersection ID: 14132	Main Street: LEXINGTON_AV	Cross Street: MT_VERNON_AV	Location: NW
ADA ID: D82B2B5B22EF	Ramp Type: Directional1	Initial Pass/Fail: Fail	Overall Compliance: No
		Severity Score: 12.5

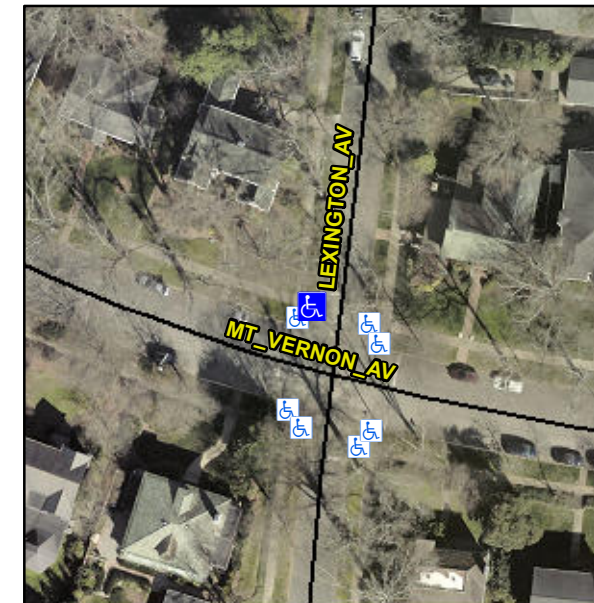
R304.2.2

Compliance	Description	Data	Compliance	Description	Data
N/A	Ramp Length (in)	67.0	N/A	Grade Break?	N/A
Yes	Ramp Width (in)	59.0	N/A	Grade Break Slope (%)	0.0
No	Ramp Slope (%)	10.1	N/A	Grade Break XSlope (%)	0.0
Yes	Ramp XSlope (%)	0.4			
N/A	Flare Type LT	N/A	N/A	Flare Type RT	N/A
N/A	Flare Slope LT (%)	N/A	N/A	Flare Slope RT (%)	0.0
N/A	Flare Traversable LT?	N/A	N/A	Flare Traversable RT?	N/A
N/A	Landing Length (in)	0.0	N/A	DWS Provided?	N/A
N/A	Landing Width (in)	0.0	N/A	DWS Contrast?	N/A
N/A	Landing Slope (%)	0.0	N/A	DWS Length (in)	N/A
N/A	Landing X Slope (%)	0.0	N/A	DWS Full Width?	N/A
N/A	Landing Curb? (Y/N)	N/A	N/A	DWS Offset LT (in)	N/A
N/A	Shared Landing?	N/A	N/A	DWS Offset RT (in)	N/A
N/A	Gutter Ponding?	0.0	N/A	Gutter Slope (%)	N/A
N/A	Gutter Lip Ht (in)	0.0	N/A	Gutter X Slope (%)	N/A
N/A	Painted X Walk1?	No		Road Slope (%)	4.8
	X Walk 1 Direction	To E		Road X Slope (%)	3.3
	X Walk 1 Width (in)	N/A		Clear Space?	N/A

X Walk 1 Slope (%)	4.8	N/A	Clear Space to XWalk (in)	N/A
	X Walk 1 X Slope (%)	3.3	N/A	Storm Grate/Utility Hazard?	N/A
N/A	Ramp inside XWalk1?	N/A		Storm Grate/Utility Type	
N/A	Any Obstructions?	N/A			N/A
	Obstruction Type		Yes	Surface Condition? (G/P)	Good
			N/A	Curb Slope (%)	18.5

Possible Solutions:

Remove & Replace Entire Ramp.
