Access Compliance Report

Public Rights-of-Way

(Curb Ramps)

Intersection ID: 32314	Main Street: CAMDEN TRAIL CT	Cross Street: NEW PROVIDENCE LN	Location: SE
ADA ID: D82FE7BC59C4	Ramp Type: PerpDiag	Initial Pass/Fail: Pass	Overall Compliance: No
		Severity Score: 20

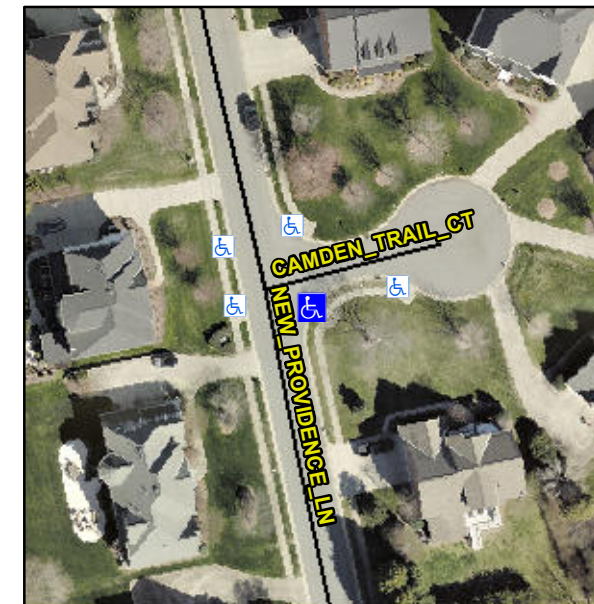
Compliance	Description	Data	Compliance	Description	Data
N/A	Ramp Length (in)	97.0	Yes	Ramp Slope (%)	6.8
Yes	Ramp Width (in)	48.0	Yes	Ramp XSlope (%)	0.6
N/A	Flare Type LT	None	N/A	Flare Type RT	N/A
N/A	Flare Slope LT (%)	N/A	N/A	Flare Slope RT (%)	N/A
N/A	Flare Traversable LT?	N/A	N/A	Flare Traversable RT?	N/A
No	Landing Length (in)	N/A	No	DWS Provided?	No
No	Landing Width (in)	N/A	N/A	DWS Contrast?	No
No	Landing Slope (%)	N/A	N/A	DWS Length (in)	N/A
No	Landing X Slope (%)	N/A	N/A	DWS Full Width?	No
N/A	Landing Curb? (Y/N)	No	N/A	DWS Offset (in)	N/A
N/A	Shared Landing?	No			
Yes	Gutter Ponding?	No	Yes	Gutter Slope (%)	3.3
Yes	Gutter Lip Ht (in)	0.0	Yes	Gutter X Slope (%)	1.3
N/A	Painted X Walk1?	No	N/A	Painted X Walk2?	No
	X Walk 1 Direction	To N		X Walk 2 Direction	To W
N/A	X Walk 1 Width (in)	N/A	N/A	X Walk 2 Width (in)	N/A
	X Walk 1 Slope (%)	0.7		X Walk 2 Slope (%)	1.9
	X Walk 1 X Slope (%)	2.0		X Walk 2 X Slope (%)	0.6

N/A	Ramp inside XWalk1?	N/A	N/A	Ramp inside XWalk2?	N/A
	Road Slope (%)	0.1	N/A	Clear Space?	Yes
	Road X Slope (%)	2.1	N/A	Clear Space to XWalk (in)	N/A
Yes	Any Obstructions?	No	Yes	Storm Grate/Utility Hazard?	No
	Obstruction Type			Storm Grate/Utility Type	
		N/A			N/A
			Yes	Surface Condition? (G/P)	Good

Remove & Replace Curb Ramp With Two New Directional Ramps or Equivalent.

R304.2.1, R304.2.2-Perp, R304.3.2-Para, R304.5.3, R305
