## **Access Compliance Report Public Rights-of-Way** (Curb Ramps)

Intersection ID: 46785 Main Street: DOMINION\_VILLAGE\_DR **Cross Street: AUTUMN HARVEST LN** Location: N Severity Score: **ADA ID: D83A0CEA7380** Ramp Type: BlendTrans1 Initial Pass/Fail: Fail **Overall Compliance: No** 8.75

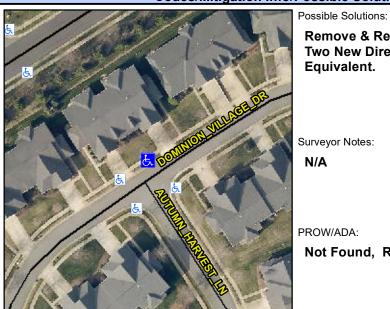
Not Found, R304.5.1

Field Measurements/Component Compliance						
Compl	liance Description	Data	Comp	liance Description	Data	
N/A	Ramp Length (in)	47.5	Yes	BlendTrans Slope (%)	2.6	
No	Ramp Width (in)	47.0	Yes	BlendTrans XSlope (%)	0.0	
N/A	Flare Type LT	N/A	N/A	Flare Type RT	N/A	
N/A	Flare Slope LT (%)	N/A	N/A	Flare Slope RT (%)	N/A	
N/A	Flare Traversable LT?	N/A	N/A	Flare Traversable RT?	N/A	
N/A	Landing Length (in)	N/A	N/A	DWS Provided?	N/A	
N/A	Landing Width (in)	N/A	N/A	DWS Contrast?	N/A	
N/A	Landing Slope (%)	N/A	N/A	DWS Length (in)	N/A	
N/A	Landing X Slope (%)	N/A	N/A	DWS Full Width?	N/A	
N/A	Landing Curb? (Y/N)	N/A	N/A	DWS Offset (in)	N/A	
N/A	Shared Landing?	N/A				
N/A	Gutter Ponding?	N/A	N/A	Gutter Slope (%)	N/A	
N/A	Gutter Lip Ht (in)	N/A	N/A	Gutter X Slope (%)	N/A	
N/A	Painted X Walk1?	No	N/A	Painted X Walk2?	N/A	
	X Walk 1 Direction	To SE		X Walk 2 Direction	N/A	
	X Walk 1 Width (in)	N/A		X Walk 2 Width (in)	N/A

X Walk 1 Slope (%)	2.7		X Walk 2 Slope (%)	N/A	
	X Walk 1 X Slope (%)	0.3		X Walk 2 X Slope (%)	N/A	
N/A	Ramp inside XWalk1?	N/A	N/A	Ramp inside XWalk2?	N/A	
	Road Slope (%)	0.3		Clear Space?	N/A	
	Road X Slope (%)	2.7	N/A	Clear Space to XWalk (in)	N/A	
N/A	Any Obstructions?	N/A	N/A	Storm Grate/Utility Hazard?	N/A	
	Obstruction Type			Storm Grate/Utility Type		
		N/A	l		N/A	
			Yes	Surface Condition? (G/P)	Good	
	and the same of th		No	Curb Slope (%)	19.0

**DOMINION VILLAGE DR** Street 1 Name Stop Condition-Street 1 None Street 2 Name N/A Stop Condition-Street 2 N/A Remove & Replace Curb Ramp With Two New Directional Ramps or Equivalent.
