Access Compliance Report

Public Rights-of-Way

(Curb Ramps)

Intersection ID: 6149	Main Street: STATESVILLE_RD	Cross Street: SUNTRACE_WY	Location: SE
ADA ID: D8409264A12E	Ramp Type: Perp	Initial Pass/Fail: Fail	Overall Compliance: No
Severity Score: 8.75			
Codes/Mitigation Info/Possible Solution		Field Measurements/Component Compliance

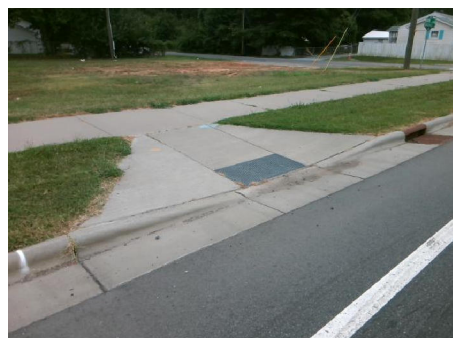
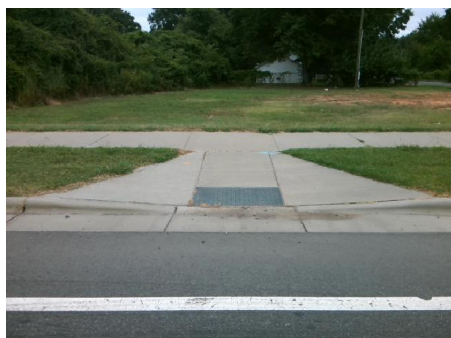
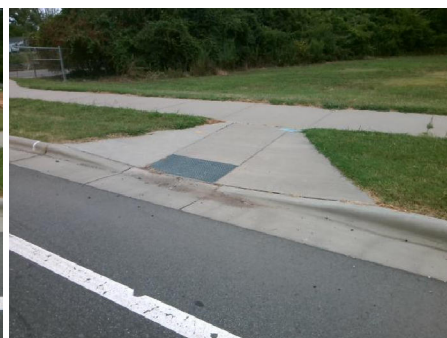
Compliance	Description	Data	Compliance	Description	Data
N/A	Ramp Length (in)	96.0	Yes	Ramp Slope (%)	7.6
No	Ramp Width (in)	47.5	Yes	Ramp XSlope (%)	0.0
N/A	Flare Type LT	N/A	N/A	Flare Type RT	N/A
N/A	Flare Slope LT (%)	N/A	N/A	Flare Slope RT (%)	N/A
N/A	Flare Traversable LT?	N/A	N/A	Flare Traversable RT?	N/A
N/A	Landing Length (in)	N/A	N/A	DWS Provided?	N/A
N/A	Landing Width (in)	N/A	N/A	DWS Contrast?	N/A
N/A	Landing Slope (%)	N/A	N/A	DWS Length (in)	N/A
N/A	Landing X Slope (%)	N/A	N/A	DWS Full Width?	N/A
N/A	Landing Curb? (Y/N)	N/A	N/A	DWS Offset (in)	N/A
N/A	Shared Landing?	N/A			
N/A	Gutter Ponding?	N/A	N/A	Gutter Slope (%)	N/A
N/A	Gutter Lip Ht (in)	N/A	N/A	Gutter X Slope (%)	N/A
N/A	Painted X Walk1?	No	N/A	Painted X Walk2?	N/A
	X Walk 1 Direction	To W		X Walk 2 Direction	N/A
N/A	X Walk 1 Width (in)	N/A	N/A	X Walk 2 Width (in)	N/A
	X Walk 1 Slope (%)	2.1		X Walk 2 Slope (%)	N/A
	X Walk 1 X Slope (%)	0.1		X Walk 2 X Slope (%)	N/A

N/A	Ramp inside XWalk1?	N/A	N/A	Ramp inside XWalk2?	N/A
	Road Slope (%)	N/A	N/A	Clear Space?	N/A
	Road X Slope (%)	N/A	N/A	Clear Space to XWalk (in)	N/A
N/A	Any Obstructions?	N/A	N/A	Storm Grate/Utility Hazard?	N/A
	Obstruction Type			Storm Grate/Utility Type	
		N/A			N/A
			Yes	Surface Condition? (G/P)	Good

Remove & Replace Entire Ramp.
