Access Compliance Report

Public Rights-of-Way

(Curb Ramps)

Intersection ID: 3717	Main Street: CLAIBORNE_WOODS_RD	Cross Street: PALOMINO_CT	Location:	W
ADA ID: D856EE3E72AF	Ramp Type: BlendTrans2	Initial Pass/Fail: Fail	Overall Compliance: No	Severity Score: 8.75
Codes/Mitigation Info/Possible Solution		Field Measurements/Component Compliance

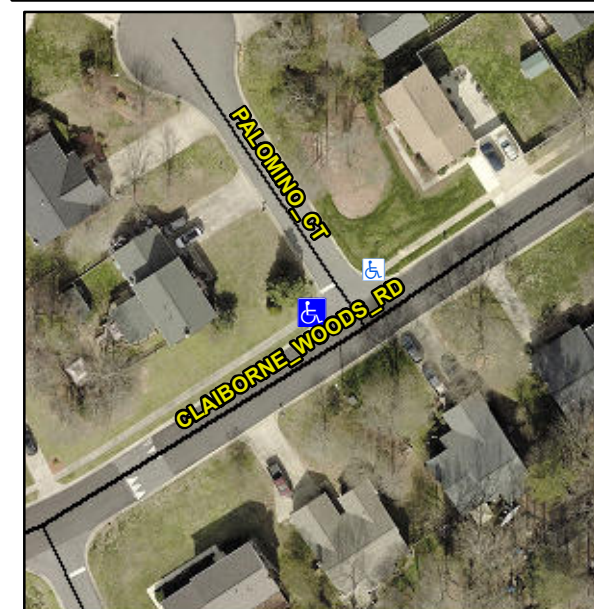
Not Found, R304.5.1

Compliance	Description	Data	Compliance	Description	Data
N/A	Ramp Length (in)	26.0	Yes	BlendTrans Slope (%)	2.9
No	Ramp Width (in)	47.5	Yes	BlendTrans XSlope (%)	1.5
N/A	Flare Type LT	N/A	N/A	Flare Type RT	N/A
N/A	Flare Slope LT (%)	N/A	N/A	Flare Slope RT (%)	N/A
N/A	Flare Traversable LT?	N/A	N/A	Flare Traversable RT?	N/A
N/A	Landing Length (in)	N/A	N/A	DWS Provided?	N/A
N/A	Landing Width (in)	N/A	N/A	DWS Contrast?	N/A
N/A	Landing Slope (%)	N/A	N/A	DWS Length (in)	N/A
N/A	Landing X Slope (%)	N/A	N/A	DWS Full Width?	N/A
N/A	Landing Curb? (Y/N)	N/A	N/A	DWS Offset (in)	N/A
N/A	Shared Landing?	N/A			
N/A	Gutter Ponding?	N/A	N/A	Gutter Slope (%)	N/A
N/A	Gutter Lip Ht (in)	N/A	N/A	Gutter X Slope (%)	N/A
N/A	Painted X Walk1?	No	N/A	Painted X Walk2?	N/A
	X Walk 1 Direction	To NE		X Walk 2 Direction	N/A
	X Walk 1 Width (in)	N/A		X Walk 2 Width (in)	N/A
	X Walk 1 Slope (%)	3.2		X Walk 2 Slope (%)	N/A
	X Walk 1 X Slope (%)	3.5		X Walk 2 X Slope (%)	N/A

N/A	Ramp inside XWalk1?	N/A	N/A	Ramp inside XWalk2?	N/A
	Road Slope (%)	3.5		Clear Space?	N/A
	Road X Slope (%)	3.2	N/A	Clear Space to XWalk (in)	N/A
N/A	Any Obstructions?	N/A	N/A	Storm Grate/Utility Hazard?	N/A
	Obstruction Type			Storm Grate/Utility Type	
		N/A			N/A
			Yes	Surface Condition? (G/P)	Good
			No	Curb Slope (%)	9.8

Remove & Replace Curb Ramp With Two New Directional Ramps or Equivalent.
