# Access Compliance Report

## Public Rights-of-Way

### (Curb Ramps)

Intersection ID: 31424	Main Street: MT_HOLLY-HUNTERSVILLE_RD	Cross Street: GARRON_POINT_DR	Location: NE
ADA ID: D859E7498A5A	Ramp Type: Perp	Initial Pass/Fail: Fail	Overall Compliance: No
Severity Score: 18.75			
Codes/Mitigation Info/Possible Solution		Field Measurements/Component Compliance

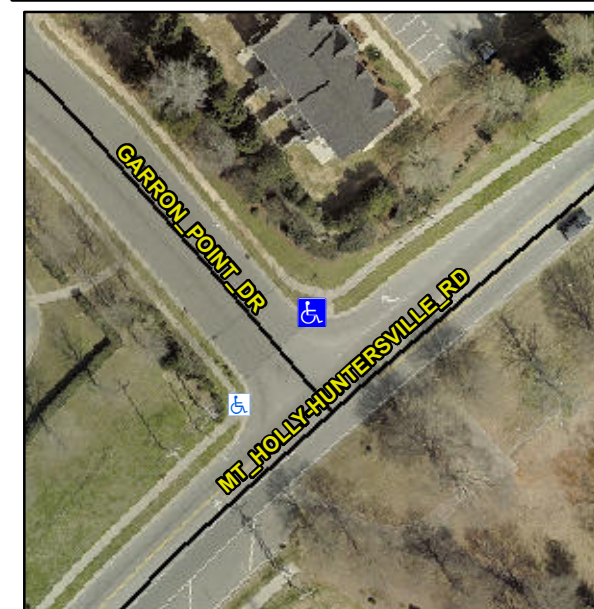
**Not Found, R304.5.1, R304.5.3**

Compliance	Description	Data	Compliance	Description	Data
N/A	Ramp Length (in)	94.0	Yes	Ramp Slope (%)	6.4
No	Ramp Width (in)	35.0	No	Ramp XSlope (%)	2.9
N/A	Flare Type LT	N/A	N/A	Flare Type RT	N/A
N/A	Flare Slope LT (%)	N/A	N/A	Flare Slope RT (%)	N/A
N/A	Flare Traversable LT?	N/A	N/A	Flare Traversable RT?	N/A
N/A	Landing Length (in)	N/A	N/A	DWS Provided?	N/A
N/A	Landing Width (in)	N/A	N/A	DWS Contrast?	N/A
N/A	Landing Slope (%)	N/A	N/A	DWS Length (in)	N/A
N/A	Landing X Slope (%)	N/A	N/A	DWS Full Width?	N/A
N/A	Landing Curb? (Y/N)	N/A	N/A	DWS Offset (in)	N/A
N/A	Shared Landing?	N/A			
N/A	Gutter Ponding?	N/A	N/A	Gutter Slope (%)	N/A
N/A	Gutter Lip Ht (in)	N/A	N/A	Gutter X Slope (%)	N/A
N/A	Painted X Walk1?	No	N/A	Painted X Walk2?	N/A
	X Walk 1 Direction	To SW		X Walk 2 Direction	N/A
N/A	X Walk 1 Width (in)	N/A	N/A	X Walk 2 Width (in)	N/A
	X Walk 1 Slope (%)	1.5		X Walk 2 Slope (%)	N/A
	X Walk 1 X Slope (%)	5.7		X Walk 2 X Slope (%)	N/A

N/A	Ramp inside XWalk1?	N/A	N/A	Ramp inside XWalk2?	N/A
	Road Slope (%)	N/A	N/A	Clear Space?	N/A
	Road X Slope (%)	N/A	N/A	Clear Space to XWalk (in)	N/A
N/A	Any Obstructions?	N/A	N/A	Storm Grate/Utility Hazard?	N/A
	Obstruction Type			Storm Grate/Utility Type	
		N/A			N/A
		Yes		Surface Condition? (G/P)	Good

**Remove & Replace Entire Ramp.**

Total Cost: \$ 1850.00
