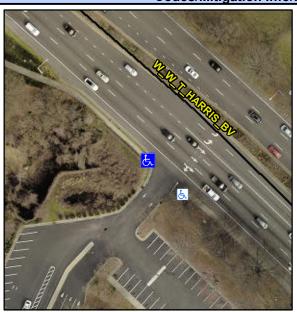
Intersection ID: 10014099 Main Street: W W T HARRIS BV **Cross Street: N/A** Location: ADA ID: D8623F84E918 Ramp Type: ParaDiag Initial Pass/Fail: Fail **Overall Compliance: No** Severity Score: 13.75

Field Measurements/Component Compliance					
Compliance Description		Data	Comp	liance Description	Data
N/A	Ramp Length LT (in)	40.0	N/A	Ramp Length RT (in)	50.0
Yes	Ramp Width LT (in)	60.0	Yes	Ramp Width RT (in)	60.0
Yes	Ramp Slope LT (%)	1.3	No	Ramp Slope RT (%)	8.9
No	Ramp XSlope LT (%)	2.3	No	Ramp XSlope RT (%)	3.9
N/A	Landing Length (in)	N/A	N/A	DWS Provided?	N/A
N/A	Landing Width (in)	N/A	N/A	DWS Contrast?	N/A
N/A	Landing Slope (%)	N/A	N/A	DWS Length (in)	N/A
N/A	Landing X Slope (%)	N/A	N/A	DWS Full Width?	N/A
N/A	Landing Curb? (Y/N)	N/A	N/A	DWS Offset (in)	N/A
N/A	Shared Landing?	N/A			
N/A	Gutter Ponding?	N/A	N/A	Gutter Slope (%)	N/A
N/A	Gutter Lip Ht (in)	N/A	N/A	Gutter X Slope (%)	N/A
N/A	Painted X Walk1?	No	N/A	Painted X Walk2?	No
	X Walk 1 Direction	To SE		X Walk 2 Direction	To NE
N/A	X Walk 1 Width (in)	N/A	N/A	X Walk 2 Width (in)	N/A
	X Walk 1 Slope (%)	3.6		X Walk 2 Slope (%)	10.2
	X Walk 1 X Slope (%)	7.3		X Walk 2 X Slope (%)	0.9

N/A	Ramp inside XWalk1?	N/A	N/A	Ramp inside XWalk2?	N/A
	Road Slope (%)	2.4	N/A	Clear Space?	N/A
	Road X Slope (%)	6.6	N/A	Clear Space to XWalk (in)	N/A
N/A	Any Obstructions?	N/A	N/A	Storm Grate/Utility Hazard?	N/A
	Obstruction Type			Storm Grate/Utility Type	
		N/A			N/A
			Yes	Surface Condition? (G/P)	Good
			N/A	Curb Slope (%)	0.9
		·

ENTRANCE Street 1 Name Stop Condition-Street 1 None Street 2 Name W W T HARRIS BV Stop Condition-Street 2 None Possible Solutions: Remove & Replace Curb Ramp With **Two New Directional Ramps or** Equivalent. Surveyor Notes: **MEDIAN ACROSS W W T HARRIS** BV PROW/ADA: R304.5.3, R304.3.2
