## **Access Compliance Report Public Rights-of-Way** (Curb Ramps)

Intersection ID: 45522 Main Street: LANSFORD RD **Cross Street: WILBURN CT** Location: W **Overall Compliance: No Severity Score:** 25 ADA ID: D863194AB1A3 Ramp Type: PerpDiag Initial Pass/Fail: Fail

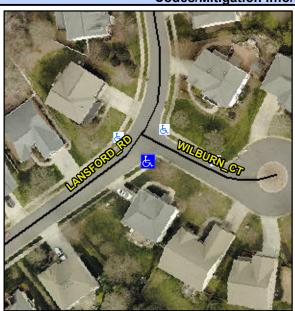
WILBURN CT Street 1 Name Stop Condition-Street 2 StopSign LANSFORD RD Street 2 Name Stop Condition-Street 1 None Possible Solutions: Remove & Replace Curb Ramp With Two New Directional Ramps or Equivalent. Surveyor Notes: N/A PROW/ADA: R304.5.3
