Access Compliance Report

Public Rights-of-Way

(Curb Ramps)

Intersection ID: 10035049	Main Street: PROVIDENCE_RD	Cross Street: N/A	Location: NE
ADA ID: D865D6E64065	Ramp Type: Directional1	Initial Pass/Fail: Fail	Overall Compliance: No
Severity Score: 1.25			
Codes/Mitigation Info/Possible Solution		Field Measurements/Component Compliance

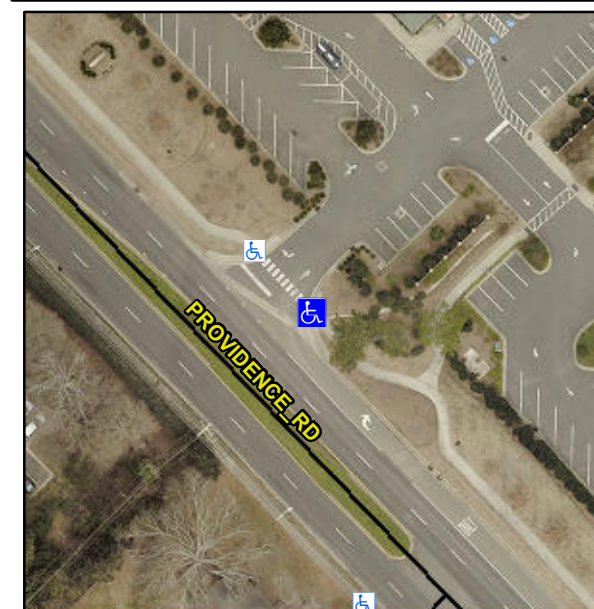
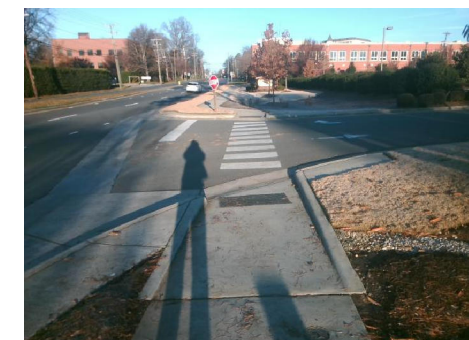
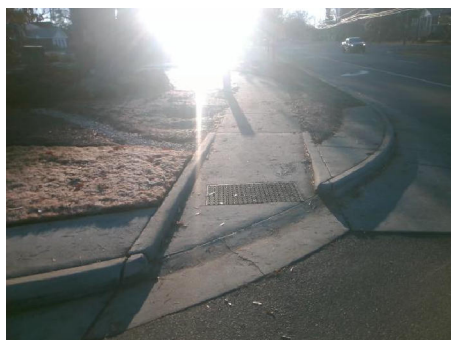
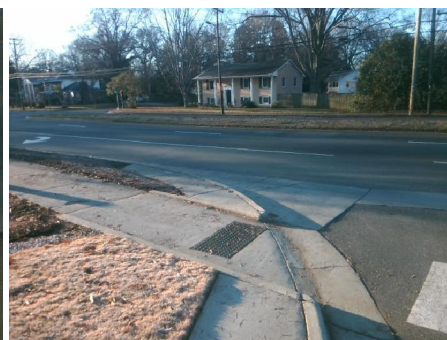
R304.5.3

Compliance	Description	Data	Compliance	Description	Data
N/A	Ramp Length (in)	119.0	N/A	Grade Break?	N/A
Yes	Ramp Width (in)	69.0	N/A	Grade Break Slope (%)	0.0
Yes	Ramp Slope (%)	2.5	N/A	Grade Break XSlope (%)	0.0
No	Ramp XSlope (%)	2.2			
N/A	Flare Type LT	N/A	N/A	Flare Type RT	N/A
N/A	Flare Slope LT (%)	N/A	N/A	Flare Slope RT (%)	0.0
N/A	Flare Traversable LT?	N/A	N/A	Flare Traversable RT?	N/A
N/A	Landing Length (in)	0.0	N/A	DWS Provided?	N/A
N/A	Landing Width (in)	0.0	N/A	DWS Contrast?	N/A
N/A	Landing Slope (%)	0.0	N/A	DWS Length (in)	N/A
N/A	Landing X Slope (%)	0.0	N/A	DWS Full Width?	N/A
N/A	Landing Curb? (Y/N)	N/A	N/A	DWS Offset LT (in)	N/A
N/A	Shared Landing?	N/A	N/A	DWS Offset RT (in)	N/A
N/A	Gutter Ponding?	0.0	N/A	Gutter Slope (%)	N/A
N/A	Gutter Lip Ht (in)	0.0	N/A	Gutter X Slope (%)	N/A
N/A	Painted X Walk1?	Yes		Road Slope (%)	5.1
	X Walk 1 Direction	To NW		Road X Slope (%)	3.5
	X Walk 1 Width (in)	60.3		Clear Space?	N/A

X Walk 1 Slope (%)	5.1	N/A	Clear Space to XWalk (in)	N/A
	X Walk 1 X Slope (%)	3.5	N/A	Storm Grate/Utility Hazard?	N/A
N/A	Ramp inside XWalk1?	Yes		Storm Grate/Utility Type	
N/A	Any Obstructions?	N/A			N/A
	Obstruction Type		Yes	Surface Condition? (G/P)	Good
			N/A	Curb Slope (%)	13.5

Possible Solutions:

Remove & Replace Entire Ramp.
