# Access Compliance Report

## Public Rights-of-Way

### (Curb Ramps)

| Intersection ID: 30297 | Main Street: BLACK_KETTLE_DR | Cross Street: MAGLEV_LN | Location: | N |

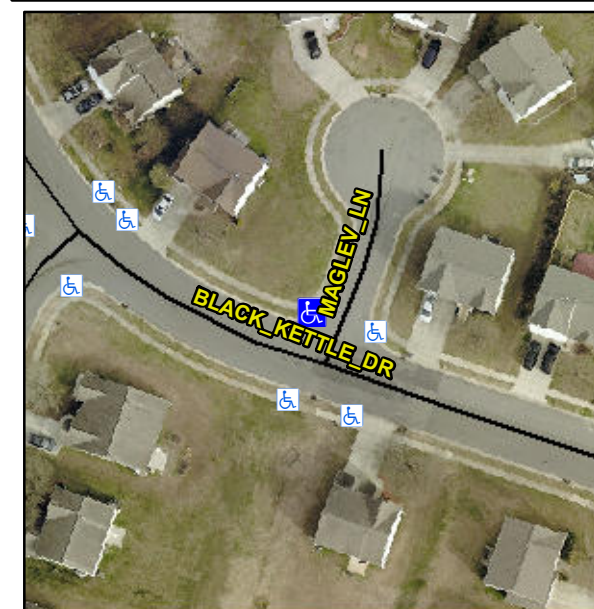
| ADA ID: D86A1D524AA6 | Ramp Type: PerpDiag | Initial Pass/Fail: Pass | Overall Compliance: No | Severity Score: 22.75 |

**R304.5.3, R304.2.1, R304.2.2-Perp, R304.3.2-Para, R305, R302.7.2, R304.5.4**

| Compliance | Description | Data | Compliance | Description | Data |
|---|---|---|---|---|---|
| N/A | Ramp Length (in) | 49.0 | Yes | Ramp Slope (%) | 5.3 |
| Yes | Ramp Width (in) | 59.0 | No | Ramp XSlope (%) | 4.0 |
| No | Landing Length (in) | 47.0 | No | DWS Provided? | No |
| No | Landing Slope (%) | 3.7 | N/A | DWS Length (in) | N/A |
| No | Landing X Slope (%) | 3.0 | N/A | DWS Full Width? | No |
| Yes | Gutter Ponding? | No | No | Gutter Slope (%) | 8.4 |
| No | Gutter Lip Ht (in) | 0.5 | No | Gutter X Slope (%) | 4.8 |

Possible Solutions:

**Remove & Replace Curb Ramp With Two New Directional Ramps or Equivalent. Remove & Replace Gutter.**

Total Cost: \$ 3950.00
