Access Compliance Report

Public Rights-of-Way

(Curb Ramps)

Intersection ID: 10020420	Main Street: BALLANTYNE_VILLAGE_WY	Cross Street: N/A	Location: E
ADA ID: D86BB980C163	Ramp Type: Perp	Initial Pass/Fail: Fail	Overall Compliance: No
Severity Score: 13.75			
Codes/Mitigation Info/Possible Solution		Field Measurements/Component Compliance

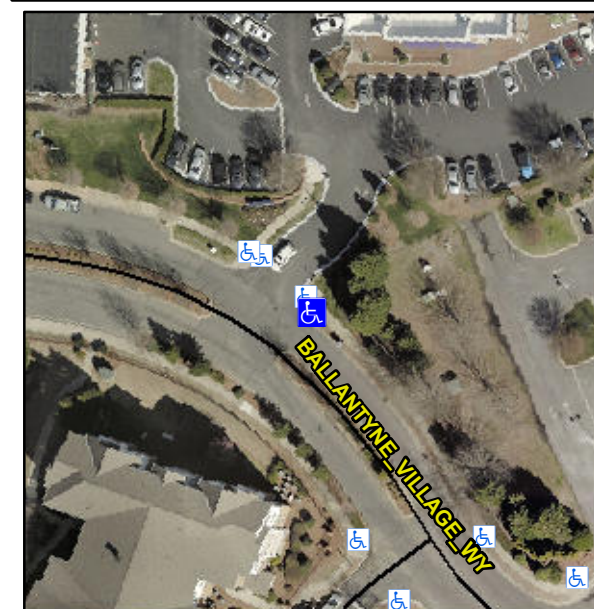
R304.2.2, R304.5.3

Compliance	Description	Data	Compliance	Description	Data
N/A	Ramp Length (in)	104.0	No	Ramp Slope (%)	9.6
Yes	Ramp Width (in)	59.0	No	Ramp XSlope (%)	4.9
N/A	Flare Type LT	N/A	N/A	Flare Type RT	N/A
N/A	Flare Slope LT (%)	N/A	N/A	Flare Slope RT (%)	N/A
N/A	Flare Traversable LT?	N/A	N/A	Flare Traversable RT?	N/A
N/A	Landing Length (in)	N/A	N/A	DWS Provided?	N/A
N/A	Landing Width (in)	N/A	N/A	DWS Contrast?	N/A
N/A	Landing Slope (%)	N/A	N/A	DWS Length (in)	N/A
N/A	Landing X Slope (%)	N/A	N/A	DWS Full Width?	N/A
N/A	Landing Curb? (Y/N)	N/A	N/A	DWS Offset (in)	N/A
N/A	Shared Landing?	N/A			
N/A	Gutter Ponding?	N/A	N/A	Gutter Slope (%)	N/A
N/A	Gutter Lip Ht (in)	N/A	N/A	Gutter X Slope (%)	N/A
N/A	Painted X Walk1?	No	N/A	Painted X Walk2?	N/A
	X Walk 1 Direction	To SW		X Walk 2 Direction	N/A
N/A	X Walk 1 Width (in)	N/A	N/A	X Walk 2 Width (in)	N/A
	X Walk 1 Slope (%)	4.4		X Walk 2 Slope (%)	N/A
	X Walk 1 X Slope (%)	1.8		X Walk 2 X Slope (%)	N/A

N/A	Ramp inside XWalk1?	N/A	N/A	Ramp inside XWalk2?	N/A
	Road Slope (%)	N/A	N/A	Clear Space?	N/A
	Road X Slope (%)	N/A	N/A	Clear Space to XWalk (in)	N/A
N/A	Any Obstructions?	N/A	N/A	Storm Grate/Utility Hazard?	N/A
	Obstruction Type			Storm Grate/Utility Type	
		N/A			N/A
			Yes	Surface Condition? (G/P)	Good

Possible Solutions:

Remove & Replace Entire Ramp.

Total Cost: \$ 1850.00
