# Access Compliance Report

## Public Rights-of-Way

### (Curb Ramps)

Intersection ID: 15660	Main Street: PRESSLEY_RD	Cross Street: ROSE_RIDGE_PL	Location: E
ADA ID: D87749CFB9B3	Ramp Type: PerpDiag	Initial Pass/Fail: Fail	Overall Compliance: No
		Severity Score: 25

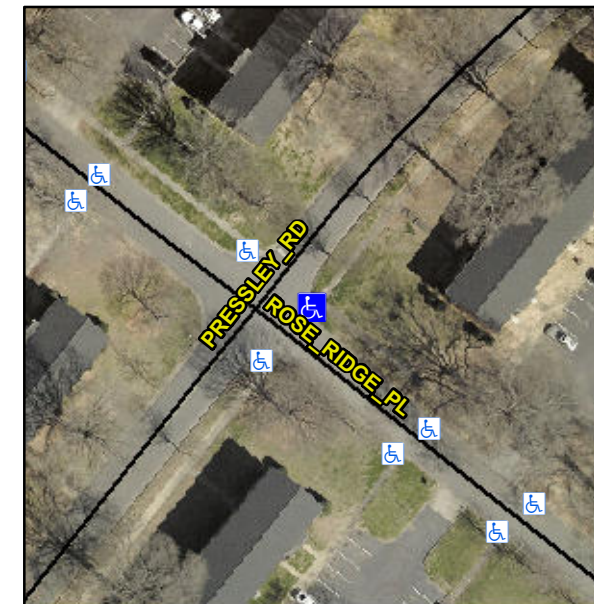
**Not Found, R304.5.3**

Compliance	Description	Data	Compliance	Description	Data
N/A	Ramp Length (in)	75.0	Yes	Ramp Slope (%)	6.2
Yes	Ramp Width (in)	48.0	No	Ramp XSlope (%)	7.8
N/A	Flare Type LT	N/A	N/A	Flare Type RT	N/A
N/A	Flare Slope LT (%)	N/A	N/A	Flare Slope RT (%)	N/A
N/A	Flare Traversable LT?	N/A	N/A	Flare Traversable RT?	N/A
N/A	Landing Length (in)	N/A	N/A	DWS Provided?	N/A
N/A	Landing Width (in)	N/A	N/A	DWS Contrast?	N/A
N/A	Landing Slope (%)	N/A	N/A	DWS Length (in)	N/A
N/A	Landing X Slope (%)	N/A	N/A	DWS Full Width?	N/A
N/A	Landing Curb? (Y/N)	N/A	N/A	DWS Offset (in)	N/A
N/A	Shared Landing?	N/A			
N/A	Gutter Ponding?	N/A	N/A	Gutter Slope (%)	N/A
N/A	Gutter Lip Ht (in)	N/A	N/A	Gutter X Slope (%)	N/A
N/A	Painted X Walk1?	No	N/A	Painted X Walk2?	No
	X Walk 1 Direction	To NW		X Walk 2 Direction	To SW
N/A	X Walk 1 Width (in)	N/A	N/A	X Walk 2 Width (in)	N/A
	X Walk 1 Slope (%)	2.6		X Walk 2 Slope (%)	5.1
	X Walk 1 X Slope (%)	6.2		X Walk 2 X Slope (%)	0.8

N/A	Ramp inside XWalk1?	N/A	N/A	Ramp inside XWalk2?	N/A
	Road Slope (%)	2.3	N/A	Clear Space?	N/A
	Road X Slope (%)	7.1	N/A	Clear Space to XWalk (in)	N/A
N/A	Any Obstructions?	N/A	N/A	Storm Grate/Utility Hazard?	N/A
	Obstruction Type			Storm Grate/Utility Type	
		N/A			N/A
			Yes	Surface Condition? (G/P)	Good

**Remove & Replace Curb Ramp With Two New Directional Ramps or Equivalent.**

Total Cost: \$ 3200.00
