# Access Compliance Report

## Public Rights-of-Way

### (Curb Ramps)

Intersection ID: 12521	Main Street: BELVEDERE_AV	Cross Street: CHATHAM_AV	Location: SE
ADA ID: D87E4F3FC2AB	Ramp Type: Perp	Initial Pass/Fail: Fail	Overall Compliance: No
Severity Score: 21.25			
Codes/Mitigation Info/Possible Solution		Field Measurements/Component Compliance

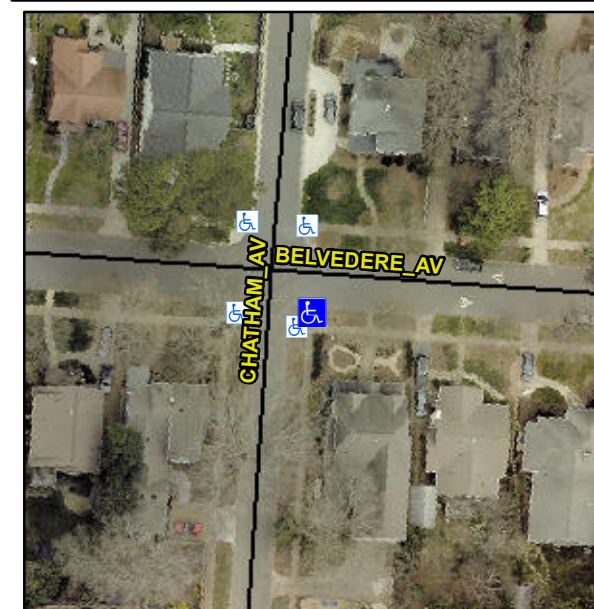
Compliance	Description	Data	Compliance	Description	Data
N/A	Ramp Length (in)	52.0	No	Ramp Slope (%)	11.5
No	Ramp Width (in)	41.0	Yes	Ramp XSlope (%)	1.5
N/A	Flare Type LT	N/A	N/A	Flare Type RT	N/A
N/A	Flare Slope LT (%)	N/A	N/A	Flare Slope RT (%)	N/A
N/A	Flare Traversable LT?	N/A	N/A	Flare Traversable RT?	N/A
N/A	Landing Length (in)	N/A	N/A	DWS Provided?	N/A
N/A	Landing Width (in)	N/A	N/A	DWS Contrast?	N/A
N/A	Landing Slope (%)	N/A	N/A	DWS Length (in)	N/A
N/A	Landing X Slope (%)	N/A	N/A	DWS Full Width?	N/A
N/A	Landing Curb? (Y/N)	N/A	N/A	DWS Offset (in)	N/A
N/A	Shared Landing?	N/A			
N/A	Gutter Ponding?	Yes	N/A	Gutter Slope (%)	N/A
N/A	Gutter Lip Ht (in)	N/A	N/A	Gutter X Slope (%)	N/A
N/A	Painted X Walk1?	No	N/A	Painted X Walk2?	N/A
	X Walk 1 Direction	To N		X Walk 2 Direction	N/A
N/A	X Walk 1 Width (in)	N/A	N/A	X Walk 2 Width (in)	N/A
	X Walk 1 Slope (%)	5.6		X Walk 2 Slope (%)	N/A
	X Walk 1 X Slope (%)	3.6		X Walk 2 X Slope (%)	N/A

N/A	Ramp inside XWalk1?	N/A	N/A	Ramp inside XWalk2?	N/A
	Road Slope (%)	N/A	N/A	Clear Space?	N/A
	Road X Slope (%)	N/A	N/A	Clear Space to XWalk (in)	N/A
N/A	Any Obstructions?	N/A	N/A	Storm Grate/Utility Hazard?	N/A
	Obstruction Type			Storm Grate/Utility Type	
		N/A			N/A
		Yes		Surface Condition? (G/P)	Good

Possible Solutions:

**Remove & Replace Entire Ramp.**

**R304.5.1, R304.2.2**

Total Cost: \$ 1850.00
