# Access Compliance Report

## Public Rights-of-Way

### (Curb Ramps)

Intersection ID: 30402	Main Street: WOODLAWN_RD	Cross Street: PARK_RD_SHOPPING_CENTER_DR	Location: SW
ADA ID: D885306330DA	Ramp Type: PerpDiag	Initial Pass/Fail: Fail	Overall Compliance: No
Severity Score: 22.5			
Codes/Mitigation Info/Possible Solution		Field Measurements/Component Compliance

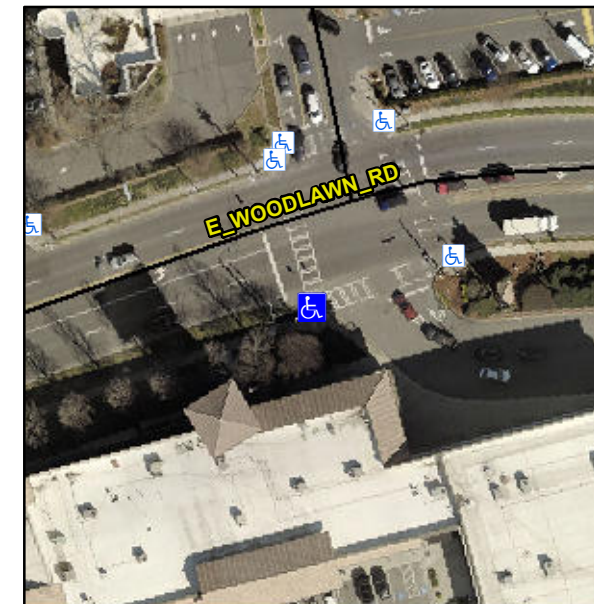
**Not Found, R304.5.1, R304.2.2, R304.5.3**

Compliance	Description	Data	Compliance	Description	Data
N/A	Ramp Length (in)	72.0	No	Ramp Slope (%)	8.7
No	Ramp Width (in)	43.0	No	Ramp XSlope (%)	2.7
N/A	Flare Type LT	N/A	N/A	Flare Type RT	N/A
N/A	Flare Slope LT (%)	N/A	N/A	Flare Slope RT (%)	N/A
N/A	Flare Traversable LT?	N/A	N/A	Flare Traversable RT?	N/A
N/A	Landing Length (in)	N/A	N/A	DWS Provided?	N/A
N/A	Landing Width (in)	N/A	N/A	DWS Contrast?	N/A
N/A	Landing Slope (%)	N/A	N/A	DWS Length (in)	N/A
N/A	Landing X Slope (%)	N/A	N/A	DWS Full Width?	N/A
N/A	Landing Curb? (Y/N)	N/A	N/A	DWS Offset (in)	N/A
N/A	Shared Landing?	N/A			
N/A	Gutter Ponding?	N/A	N/A	Gutter Slope (%)	N/A
N/A	Gutter Lip Ht (in)	N/A	N/A	Gutter X Slope (%)	N/A
N/A	Painted X Walk1?	Yes	N/A	Painted X Walk2?	Yes
	X Walk 1 Direction	To E		X Walk 2 Direction	To N
N/A	X Walk 1 Width (in)	111.0	N/A	X Walk 2 Width (in)	103.0
	X Walk 1 Slope (%)	0.6		X Walk 2 Slope (%)	1.6
	X Walk 1 X Slope (%)	2.5		X Walk 2 X Slope (%)	2.0

N/A	Ramp inside XWalk1?	Yes	N/A	Ramp inside XWalk2?	Yes
	Road Slope (%)	2.0	N/A	Clear Space?	N/A
	Road X Slope (%)	3.4	N/A	Clear Space to XWalk (in)	N/A
N/A	Any Obstructions?	N/A	N/A	Storm Grate/Utility Hazard?	N/A
	Obstruction Type			Storm Grate/Utility Type	
		N/A			N/A
		Yes		Surface Condition? (G/P)	Good

**Remove & Replace Curb Ramp With Two New Directional Ramps or Equivalent.**
