Access Compliance Report

Public Rights-of-Way

(Curb Ramps)

Intersection ID: 14203	Main Street: E_WORTHINGTON_AV	Cross Street: SOUTH_BV	Location: E
ADA ID: D8870418C1F6	Ramp Type: PerpDiag	Initial Pass/Fail: Fail	Overall Compliance: No
Severity Score: 18.75			
Codes/Mitigation Info/Possible Solution		Field Measurements/Component Compliance

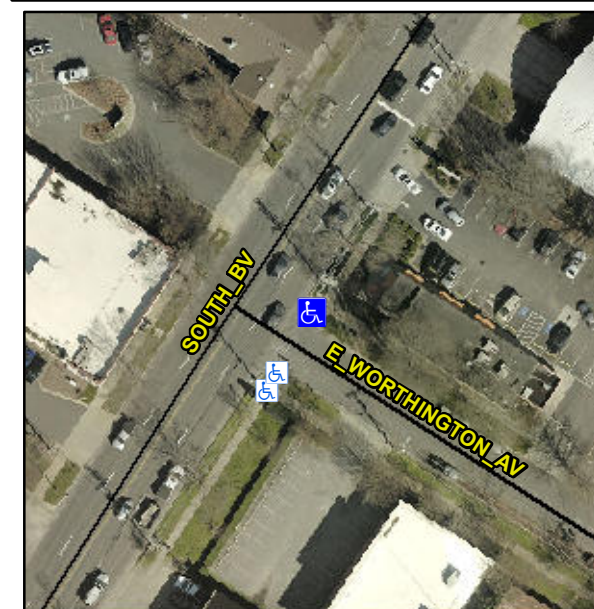
Not Found, R304.5.1, R304.5.3

Compliance	Description	Data	Compliance	Description	Data
N/A	Ramp Length (in)	57.5	Yes	Ramp Slope (%)	7.0
No	Ramp Width (in)	35.5	No	Ramp XSlope (%)	2.1
N/A	Flare Type LT	N/A	N/A	Flare Type RT	N/A
N/A	Flare Slope LT (%)	N/A	N/A	Flare Slope RT (%)	N/A
N/A	Flare Traversable LT?	N/A	N/A	Flare Traversable RT?	N/A
N/A	Landing Length (in)	N/A	N/A	DWS Provided?	N/A
N/A	Landing Width (in)	N/A	N/A	DWS Contrast?	N/A
N/A	Landing Slope (%)	N/A	N/A	DWS Length (in)	N/A
N/A	Landing X Slope (%)	N/A	N/A	DWS Full Width?	N/A
N/A	Landing Curb? (Y/N)	N/A	N/A	DWS Offset (in)	N/A
N/A	Shared Landing?	N/A			
N/A	Gutter Ponding?	N/A	N/A	Gutter Slope (%)	N/A
N/A	Gutter Lip Ht (in)	N/A	N/A	Gutter X Slope (%)	N/A
N/A	Painted X Walk1?	No	N/A	Painted X Walk2?	No
	X Walk 1 Direction	To NW		X Walk 2 Direction	To SW
N/A	X Walk 1 Width (in)	N/A	N/A	X Walk 2 Width (in)	N/A
	X Walk 1 Slope (%)	3.6		X Walk 2 Slope (%)	0.6
	X Walk 1 X Slope (%)	2.4		X Walk 2 X Slope (%)	3.2

N/A	Ramp inside XWalk1?	N/A	N/A	Ramp inside XWalk2?	N/A
	Road Slope (%)	1.2	N/A	Clear Space?	N/A
	Road X Slope (%)	2.6	N/A	Clear Space to XWalk (in)	N/A
N/A	Any Obstructions?	N/A	N/A	Storm Grate/Utility Hazard?	N/A
	Obstruction Type			Storm Grate/Utility Type	
		N/A			N/A
			Yes	Surface Condition? (G/P)	Good

Possible Solutions:

Remove & Replace Curb Ramp With Two New Directional Ramps or Equivalent.
