# Access Compliance Report

## Public Rights-of-Way

### (Curb Ramps)

| Intersection ID: 28375 | Main Street: CORNWALLIS_HALL_DR | Cross Street: WHEATFIELD_RD | Location: SW |

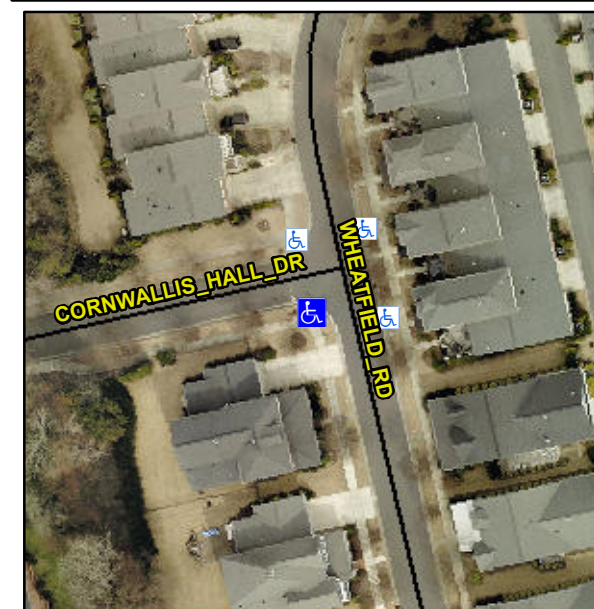
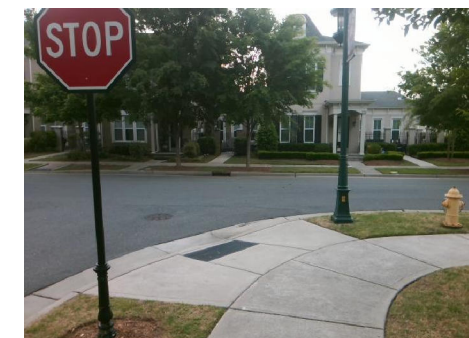
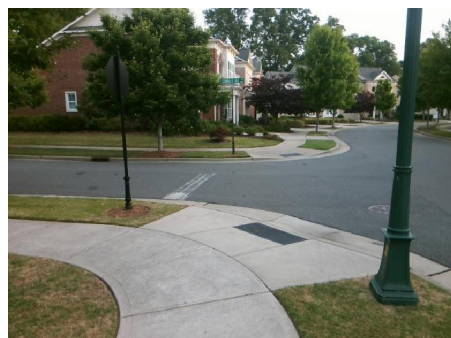
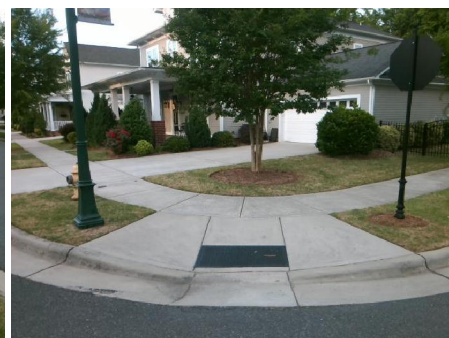
| ADA ID: D88A55E65D95 | Ramp Type: PerpDiag | Initial Pass/Fail: Fail | Overall Compliance: No |

| Severity Score: 12.5 | | | |

**Not Found, R304.2.2**

| Compliance | Description | Data | Compliance | Description | Data |
|---|---|---|---|---|---|
| N/A | Ramp Length (in) | 72.0 | No | Ramp Slope (%) | 11.1 |

**Remove & Replace Curb Ramp With Two New Directional Ramps or Equivalent.**

Total Cost: \$ 3200.00
