Access Compliance Report

Public Rights-of-Way

(Curb Ramps)

Intersection ID: 10037409	Main Street: SCHOLASTIC_DR	Cross Street: N/A	Location: SW
ADA ID: D8961070D01C	Ramp Type: PerpDiag	Initial Pass/Fail: Fail	Overall Compliance: No
Severity Score: 12.5			
Codes/Mitigation Info/Possible Solution		Field Measurements/Component Compliance

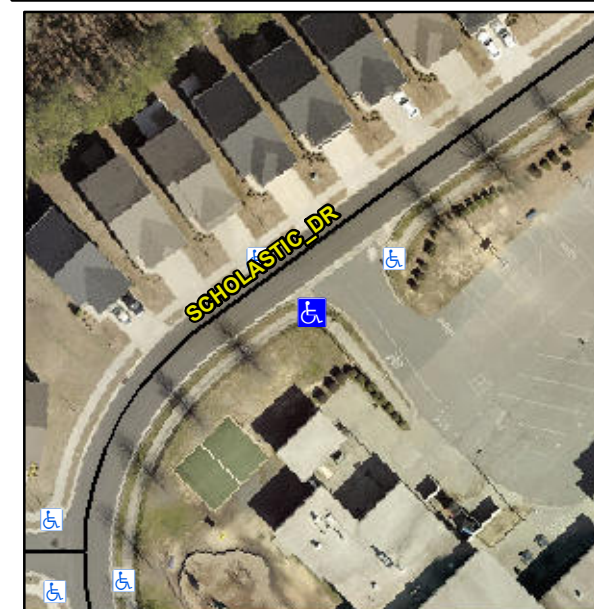
Compliance	Description	Data	Compliance	Description	Data
N/A	Ramp Length (in)	48.0	No	Ramp Slope (%)	10.1
Yes	Ramp Width (in)	48.0	Yes	Ramp XSlope (%)	0.6
N/A	Flare Type LT	N/A	N/A	Flare Type RT	N/A
N/A	Flare Slope LT (%)	N/A	N/A	Flare Slope RT (%)	N/A
N/A	Flare Traversable LT?	N/A	N/A	Flare Traversable RT?	N/A
N/A	Landing Length (in)	N/A	N/A	DWS Provided?	N/A
N/A	Landing Width (in)	N/A	N/A	DWS Contrast?	N/A
N/A	Landing Slope (%)	N/A	N/A	DWS Length (in)	N/A
N/A	Landing X Slope (%)	N/A	N/A	DWS Full Width?	N/A
N/A	Landing Curb? (Y/N)	N/A	N/A	DWS Offset (in)	N/A
N/A	Shared Landing?	N/A			
N/A	Gutter Ponding?	N/A	N/A	Gutter Slope (%)	N/A
N/A	Gutter Lip Ht (in)	N/A	N/A	Gutter X Slope (%)	N/A
N/A	Painted X Walk1?	No	N/A	Painted X Walk2?	No
	X Walk 1 Direction	To NE		X Walk 2 Direction	To NW
N/A	X Walk 1 Width (in)	N/A	N/A	X Walk 2 Width (in)	N/A
	X Walk 1 Slope (%)	0.8		X Walk 2 Slope (%)	0.4
	X Walk 1 X Slope (%)	2.3		X Walk 2 X Slope (%)	4.5

N/A	Ramp inside XWalk1?	N/A	N/A	Ramp inside XWalk2?	N/A
	Road Slope (%)	1.1	N/A	Clear Space?	N/A
	Road X Slope (%)	5.5	N/A	Clear Space to XWalk (in)	N/A
N/A	Any Obstructions?	N/A	N/A	Storm Grate/Utility Hazard?	N/A
	Obstruction Type			Storm Grate/Utility Type	
		N/A			N/A
			Yes	Surface Condition? (G/P)	Good

Possible Solutions:

Remove & Replace Curb Ramp With Two New Directional Ramps or Equivalent.

R304.2.2

\$ 3200.00
