Access Compliance Report

Public Rights-of-Way

(Curb Ramps)

Intersection ID: 30137	Main Street: DIETRICH_LN	Cross Street: RUMPLE_RD	Location: SE
ADA ID: D89E9307896C	Ramp Type: Perp	Initial Pass/Fail: Fail	Overall Compliance: No
Codes/Mitigation Info/Possible Solution			Severity Score: 10
			Field Measurements/Component Compliance

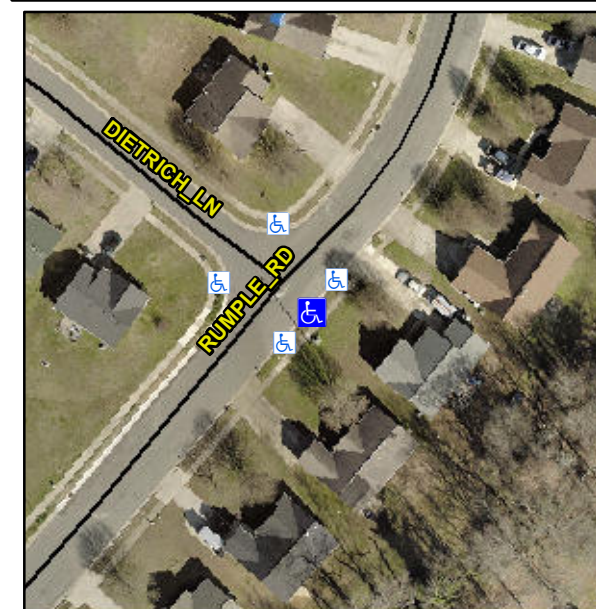
Not Found, R304.5.1, R304.5.3

Compliance	Description	Data	Compliance	Description	Data
N/A	Ramp Length (in)	48.0	Yes	Ramp Slope (%)	7.7
No	Ramp Width (in)	47.0	No	Ramp XSlope (%)	4.4
N/A	Flare Type LT	N/A	N/A	Flare Type RT	N/A
N/A	Flare Slope LT (%)	N/A	N/A	Flare Slope RT (%)	N/A
N/A	Flare Traversable LT?	N/A	N/A	Flare Traversable RT?	N/A
N/A	Landing Length (in)	N/A	N/A	DWS Provided?	N/A
N/A	Landing Width (in)	N/A	N/A	DWS Contrast?	N/A
N/A	Landing Slope (%)	N/A	N/A	DWS Length (in)	N/A
N/A	Landing X Slope (%)	N/A	N/A	DWS Full Width?	N/A
N/A	Landing Curb? (Y/N)	N/A	N/A	DWS Offset (in)	N/A
N/A	Shared Landing?	N/A			
N/A	Gutter Ponding?	N/A	N/A	Gutter Slope (%)	N/A
N/A	Gutter Lip Ht (in)	N/A	N/A	Gutter X Slope (%)	N/A
N/A	Painted X Walk1?	No	N/A	Painted X Walk2?	N/A
	X Walk 1 Direction	To NE		X Walk 2 Direction	N/A
N/A	X Walk 1 Width (in)	N/A	N/A	X Walk 2 Width (in)	N/A
	X Walk 1 Slope (%)	6.9		X Walk 2 Slope (%)	N/A
	X Walk 1 X Slope (%)	1.0		X Walk 2 X Slope (%)	N/A

N/A	Ramp inside XWalk1?	N/A	N/A	Ramp inside XWalk2?	N/A
	Road Slope (%)	N/A	N/A	Clear Space?	N/A
	Road X Slope (%)	N/A	N/A	Clear Space to XWalk (in)	N/A
N/A	Any Obstructions?	N/A	N/A	Storm Grate/Utility Hazard?	N/A
	Obstruction Type			Storm Grate/Utility Type	
		N/A			N/A
			Yes	Surface Condition? (G/P)	Good

Possible Solutions:

Remove & Replace Entire Ramp.
