Access Compliance Report

Public Rights-of-Way

(Curb Ramps)

Intersection ID: 10315	Main Street: E_34TH_ST	Cross Street: N_ALEXANDER_ST	Location: E
ADA ID: D8A7390E4F19	Ramp Type: Perp	Initial Pass/Fail: Fail	Overall Compliance: No
		Severity Score: 10

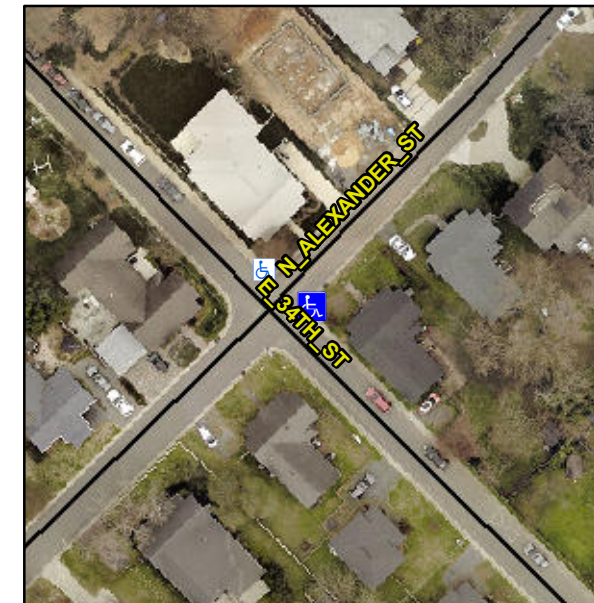
Not Found, R304.5.1

Compliance	Description	Data	Compliance	Description	Data
N/A	Ramp Length (in)	57.0	Yes	Ramp Slope (%)	6.4
No	Ramp Width (in)	41.0	Yes	Ramp XSlope (%)	3.0
N/A	Flare Type LT	N/A	N/A	Flare Type RT	N/A
N/A	Flare Slope LT (%)	N/A	N/A	Flare Slope RT (%)	N/A
N/A	Flare Traversable LT?	N/A	N/A	Flare Traversable RT?	N/A
N/A	Landing Length (in)	N/A	N/A	DWS Provided?	N/A
N/A	Landing Width (in)	N/A	N/A	DWS Contrast?	N/A
N/A	Landing Slope (%)	N/A	N/A	DWS Length (in)	N/A
N/A	Landing X Slope (%)	N/A	N/A	DWS Full Width?	N/A
N/A	Landing Curb? (Y/N)	N/A	N/A	DWS Offset (in)	N/A
N/A	Shared Landing?	N/A			
N/A	Gutter Ponding?	N/A	N/A	Gutter Slope (%)	N/A
N/A	Gutter Lip Ht (in)	1.0	N/A	Gutter X Slope (%)	N/A
N/A	Painted X Walk1?	No	N/A	Painted X Walk2?	N/A
	X Walk 1 Direction	To NW		X Walk 2 Direction	N/A
N/A	X Walk 1 Width (in)	N/A	N/A	X Walk 2 Width (in)	N/A
	X Walk 1 Slope (%)	0.3		X Walk 2 Slope (%)	N/A
	X Walk 1 X Slope (%)	3.1		X Walk 2 X Slope (%)	N/A

N/A	Ramp inside XWalk1?	N/A	N/A	Ramp inside XWalk2?	N/A
	Road Slope (%)	N/A	N/A	Clear Space?	N/A
	Road X Slope (%)	N/A	N/A	Clear Space to XWalk (in)	N/A
N/A	Any Obstructions?	N/A	N/A	Storm Grate/Utility Hazard?	N/A
	Obstruction Type			Storm Grate/Utility Type	
		N/A			N/A
			Yes	Surface Condition? (G/P)	Good

Remove & Replace Entire Ramp.

Total Cost: \$ 1850.00
