# Access Compliance Report

## Public Rights-of-Way

### (Curb Ramps)

Intersection ID: 31591	Main Street: HUGUE_WY	Cross Street: BLUE_BRIDGE_CT	Location: SW
ADA ID: D8AE612D7BA7	Ramp Type: Perp	Initial Pass/Fail: Fail	Overall Compliance: No
Severity Score: 22.5			
Codes/Mitigation Info/Possible Solution		Field Measurements/Component Compliance

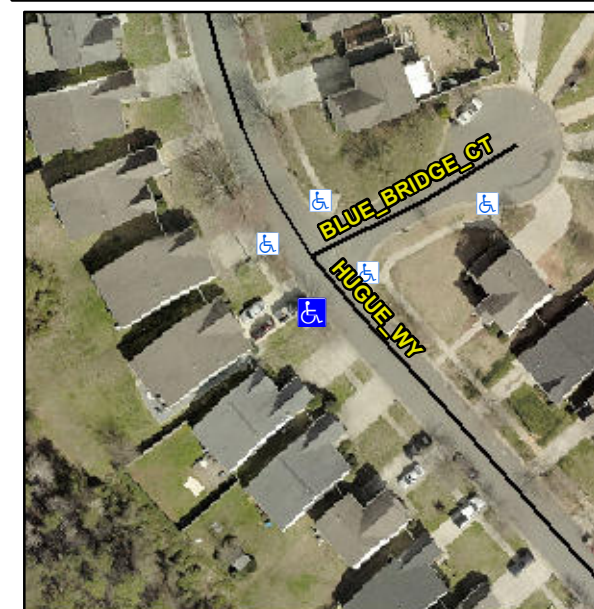
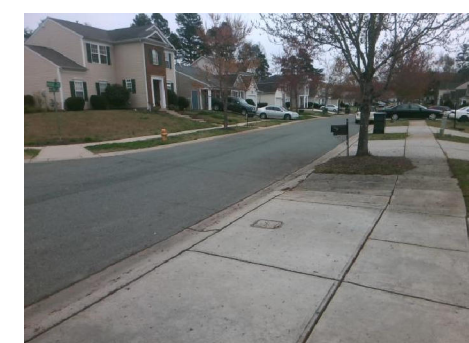
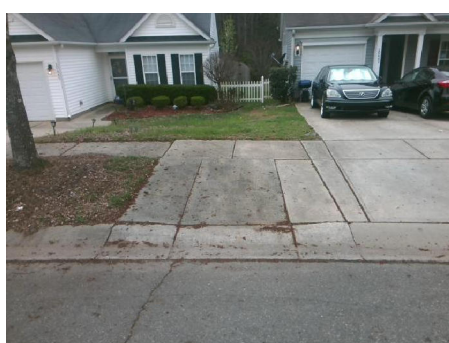
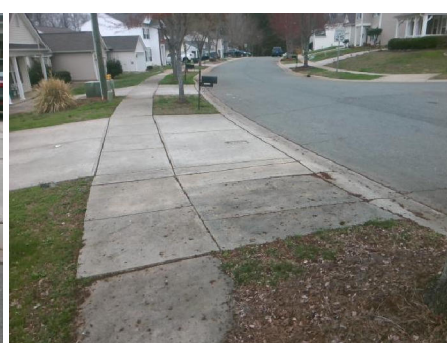
**Not Found, R304.5.1, R304.2.2, R304.5.3**

Compliance	Description	Data	Compliance	Description	Data
N/A	Ramp Length (in)	83.0	No	Ramp Slope (%)	8.7
No	Ramp Width (in)	47.0	No	Ramp XSlope (%)	2.5
N/A	Flare Type LT	N/A	N/A	Flare Type RT	N/A
N/A	Flare Slope LT (%)	N/A	N/A	Flare Slope RT (%)	N/A
N/A	Flare Traversable LT?	N/A	N/A	Flare Traversable RT?	N/A
N/A	Landing Length (in)	N/A	N/A	DWS Provided?	N/A
N/A	Landing Width (in)	N/A	N/A	DWS Contrast?	N/A
N/A	Landing Slope (%)	N/A	N/A	DWS Length (in)	N/A
N/A	Landing X Slope (%)	N/A	N/A	DWS Full Width?	N/A
N/A	Landing Curb? (Y/N)	N/A	N/A	DWS Offset (in)	N/A
N/A	Shared Landing?	N/A			
N/A	Gutter Ponding?	N/A	N/A	Gutter Slope (%)	N/A
N/A	Gutter Lip Ht (in)	N/A	N/A	Gutter X Slope (%)	N/A
N/A	Painted X Walk1?	No	N/A	Painted X Walk2?	N/A
	X Walk 1 Direction	To NE		X Walk 2 Direction	N/A
N/A	X Walk 1 Width (in)	N/A	N/A	X Walk 2 Width (in)	N/A
	X Walk 1 Slope (%)	1.4		X Walk 2 Slope (%)	N/A
	X Walk 1 X Slope (%)	0.9		X Walk 2 X Slope (%)	N/A

N/A	Ramp inside XWalk1?	N/A	N/A	Ramp inside XWalk2?	N/A
	Road Slope (%)	N/A	N/A	Clear Space?	N/A
	Road X Slope (%)	N/A	N/A	Clear Space to XWalk (in)	N/A
N/A	Any Obstructions?	N/A	N/A	Storm Grate/Utility Hazard?	N/A
	Obstruction Type			Storm Grate/Utility Type	
		N/A			N/A
			Yes	Surface Condition? (G/P)	Good

**Remove & Replace Entire Ramp.**
