Access Compliance Report

Public Rights-of-Way

(Curb Ramps)

Intersection ID: 32194	Main Street: BLAKEWOOD_DR	Cross Street: CHELTON_RIDGE_LN	Location: NE
ADA ID: D8C436973647	Ramp Type: Perp	Initial Pass/Fail: Fail	Overall Compliance: No
Severity Score: 21.25			
Codes/Mitigation Info/Possible Solution		Field Measurements/Component Compliance

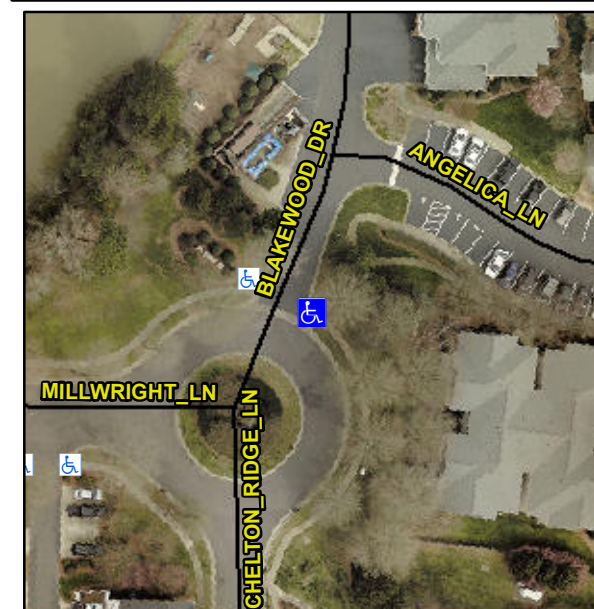
Not Found, R304.5.1, R304.2.2

Compliance	Description	Data	Compliance	Description	Data
N/A	Ramp Length (in)	145.0	No	Ramp Slope (%)	10.5
No	Ramp Width (in)	37.0	Yes	Ramp XSlope (%)	0.1
N/A	Flare Type LT	N/A	N/A	Flare Type RT	N/A
N/A	Flare Slope LT (%)	N/A	N/A	Flare Slope RT (%)	N/A
N/A	Flare Traversable LT?	N/A	N/A	Flare Traversable RT?	N/A
N/A	Landing Length (in)	N/A	N/A	DWS Provided?	N/A
N/A	Landing Width (in)	N/A	N/A	DWS Contrast?	N/A
N/A	Landing Slope (%)	N/A	N/A	DWS Length (in)	N/A
N/A	Landing X Slope (%)	N/A	N/A	DWS Full Width?	N/A
N/A	Landing Curb? (Y/N)	N/A	N/A	DWS Offset (in)	N/A
N/A	Shared Landing?	N/A			
N/A	Gutter Ponding?	N/A	N/A	Gutter Slope (%)	N/A
N/A	Gutter Lip Ht (in)	N/A	N/A	Gutter X Slope (%)	N/A
N/A	Painted X Walk1?	No	N/A	Painted X Walk2?	N/A
	X Walk 1 Direction	To NW		X Walk 2 Direction	N/A
N/A	X Walk 1 Width (in)	N/A	N/A	X Walk 2 Width (in)	N/A
	X Walk 1 Slope (%)	3.0		X Walk 2 Slope (%)	N/A
	X Walk 1 X Slope (%)	5.1		X Walk 2 X Slope (%)	N/A

Remove & Replace Entire Ramp.

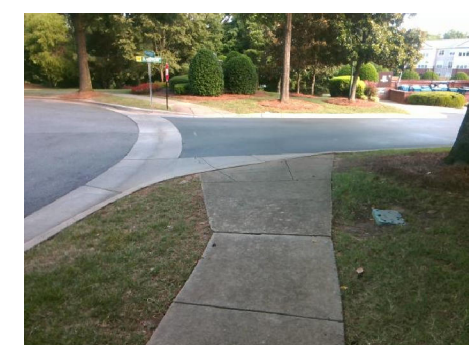
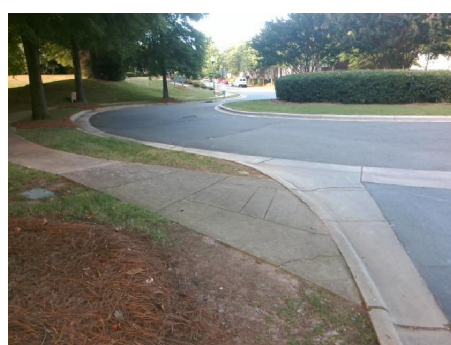
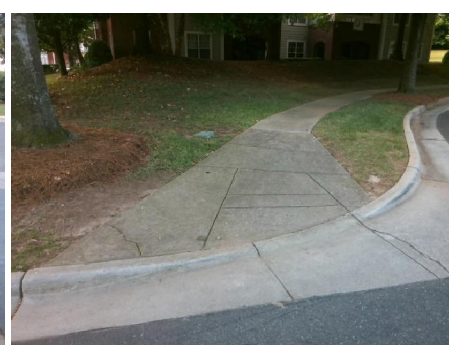
N/A	Ramp inside XWalk1?	N/A	N/A	Ramp inside XWalk2?	N/A
	Road Slope (%)	N/A	N/A	Clear Space?	N/A
	Road X Slope (%)	N/A	N/A	Clear Space to XWalk (in)	N/A
N/A	Any Obstructions?	N/A	N/A	Storm Grate/Utility Hazard?	N/A
	Obstruction Type			Storm Grate/Utility Type	
		N/A			N/A
			Yes	Surface Condition? (G/P)	Good
