# Access Compliance Report

## Public Rights-of-Way

### (Curb Ramps)

Intersection ID: 4850	Main Street: HARRINGTON_WOODS_RD	Cross Street: W_W_T_HARRIS_BV	Location: SW
ADA ID: D8C99EC2354F	Ramp Type: Perp	Initial Pass/Fail: Fail	Overall Compliance: No
Severity Score: 16.25			
Codes/Mitigation Info/Possible Solution		Field Measurements/Component Compliance

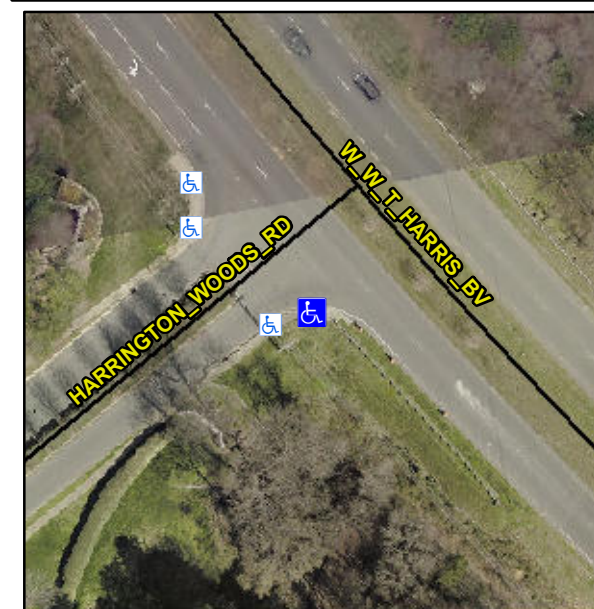
Compliance	Description	Data	Compliance	Description	Data
N/A	Ramp Length (in)	46.0	Yes	Ramp Slope (%)	5.4
Yes	Ramp Width (in)	58.0	No	Ramp XSlope (%)	4.6
N/A	Flare Type LT	N/A	N/A	Flare Type RT	N/A
N/A	Flare Slope LT (%)	N/A	N/A	Flare Slope RT (%)	N/A
N/A	Flare Traversable LT?	N/A	N/A	Flare Traversable RT?	N/A
N/A	Landing Length (in)	N/A	N/A	DWS Provided?	N/A
N/A	Landing Width (in)	N/A	N/A	DWS Contrast?	N/A
N/A	Landing Slope (%)	N/A	N/A	DWS Length (in)	N/A
N/A	Landing X Slope (%)	N/A	N/A	DWS Full Width?	N/A
N/A	Landing Curb? (Y/N)	N/A	N/A	DWS Offset (in)	N/A
N/A	Shared Landing?	N/A			
N/A	Gutter Ponding?	N/A	N/A	Gutter Slope (%)	N/A
N/A	Gutter Lip Ht (in)	N/A	N/A	Gutter X Slope (%)	N/A
N/A	Painted X Walk1?	No	N/A	Painted X Walk2?	N/A
	X Walk 1 Direction	To E		X Walk 2 Direction	N/A
N/A	X Walk 1 Width (in)	N/A	N/A	X Walk 2 Width (in)	N/A
	X Walk 1 Slope (%)	1.9		X Walk 2 Slope (%)	N/A
	X Walk 1 X Slope (%)	3.7		X Walk 2 X Slope (%)	N/A

N/A	Ramp inside XWalk1?	N/A	N/A	Ramp inside XWalk2?	N/A
	Road Slope (%)	N/A	N/A	Clear Space?	N/A
	Road X Slope (%)	N/A	N/A	Clear Space to XWalk (in)	N/A
N/A	Any Obstructions?	N/A	N/A	Storm Grate/Utility Hazard?	N/A
	Obstruction Type			Storm Grate/Utility Type	
		N/A			N/A
		No		Surface Condition? (G/P)	Poor

**Remove & Replace Entire Ramp.**

**R304.5.3, R302.7**

**\$ 1850.00**
