Access Compliance Report

Public Rights-of-Way

(Curb Ramps)

Intersection ID: N/A	Main Street: ASCENSION_WY	Cross Street: BROOKSVALE_ST	Location: NE
ADA ID: D8CFD326FF1E	Ramp Type: Perp	Initial Pass/Fail: Fail	Overall Compliance: No
Severity Score: 13.75			
Codes/Mitigation Info/Possible Solution		Field Measurements/Component Compliance

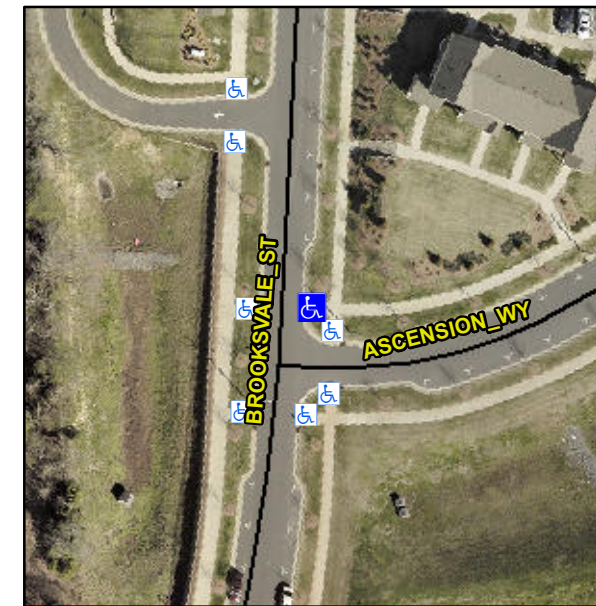
Compliance	Description	Data	Compliance	Description	Data
N/A	Ramp Length (in)	72.0	No	Ramp Slope (%)	9.6
Yes	Ramp Width (in)	70.5	No	Ramp XSlope (%)	2.2
N/A	Flare Type LT	N/A	N/A	Flare Type RT	N/A
N/A	Flare Slope LT (%)	N/A	N/A	Flare Slope RT (%)	N/A
N/A	Flare Traversable LT?	N/A	N/A	Flare Traversable RT?	N/A
N/A	Landing Length (in)	N/A	N/A	DWS Provided?	N/A
N/A	Landing Width (in)	N/A	N/A	DWS Contrast?	N/A
N/A	Landing Slope (%)	N/A	N/A	DWS Length (in)	N/A
N/A	Landing X Slope (%)	N/A	N/A	DWS Full Width?	N/A
N/A	Landing Curb? (Y/N)	N/A	N/A	DWS Offset (in)	N/A
N/A	Shared Landing?	N/A			
N/A	Gutter Ponding?	N/A	N/A	Gutter Slope (%)	N/A
N/A	Gutter Lip Ht (in)	N/A	N/A	Gutter X Slope (%)	N/A
N/A	Painted X Walk1?	No	N/A	Painted X Walk2?	N/A
	X Walk 1 Direction	To W		X Walk 2 Direction	N/A
N/A	X Walk 1 Width (in)	N/A	N/A	X Walk 2 Width (in)	N/A
	X Walk 1 Slope (%)	2.2		X Walk 2 Slope (%)	N/A
	X Walk 1 X Slope (%)	1.2		X Walk 2 X Slope (%)	N/A

N/A	Ramp inside XWalk1?	N/A	N/A	Ramp inside XWalk2?	N/A
	Road Slope (%)	N/A	N/A	Clear Space?	N/A
	Road X Slope (%)	N/A	N/A	Clear Space to XWalk (in)	N/A
N/A	Any Obstructions?	N/A	N/A	Storm Grate/Utility Hazard?	N/A
	Obstruction Type			Storm Grate/Utility Type	
		N/A			N/A
		Yes		Surface Condition? (G/P)	Good

Possible Solutions:

Remove & Replace Entire Ramp.

R304.2.2, R304.5.3
