Access Compliance Report

Public Rights-of-Way

(Curb Ramps)

Intersection ID: 6973		Main Street: DALECREST_DR		Cross Street: FINCHER_BV		Location: NE			
ADA ID: D8CFF198039B		Ramp Type: Perp		Initial Pass/Fail: Fail		Overall Compliance: No		Severity Score: 22.5	
Codes/Mitigation Info/Possible Solution					Field Measurements/Component Compliance

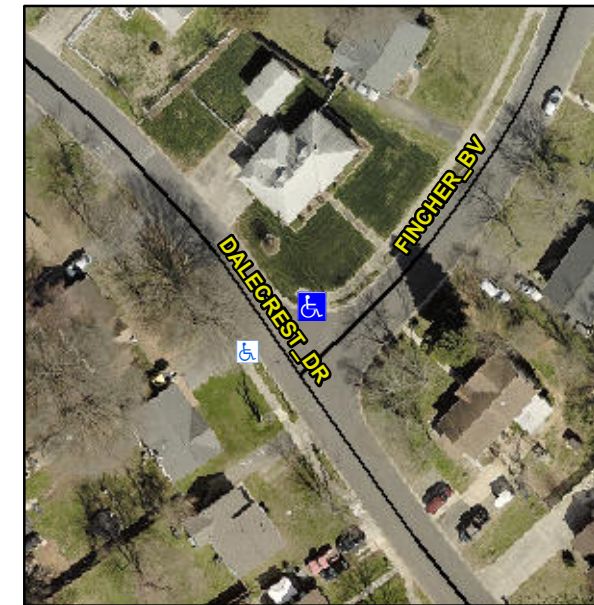
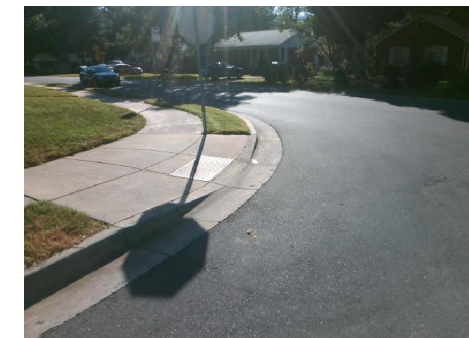
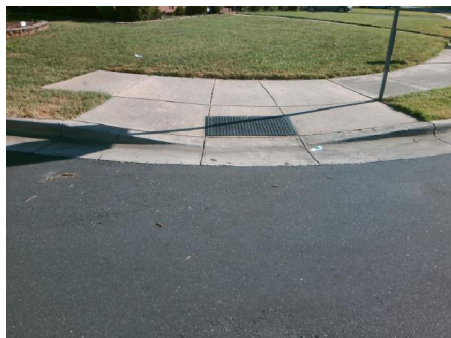
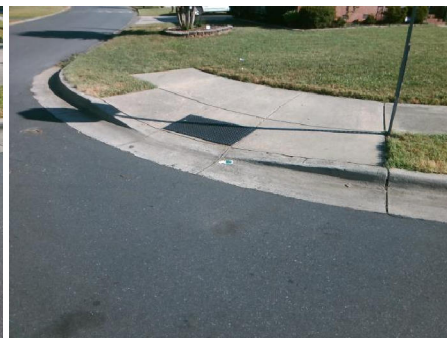
Not Found, R304.5.1, R304.2.2, R304.5.3

Compliance	Description	Data	Compliance	Description	Data
N/A	Ramp Length (in)	61.0	No	Ramp Slope (%)	8.6
No	Ramp Width (in)	39.5	No	Ramp XSlope (%)	2.6
N/A	Flare Type LT	N/A	N/A	Flare Type RT	N/A
N/A	Flare Slope LT (%)	N/A	N/A	Flare Slope RT (%)	N/A
N/A	Flare Traversable LT?	N/A	N/A	Flare Traversable RT?	N/A
N/A	Landing Length (in)	N/A	N/A	DWS Provided?	N/A
N/A	Landing Width (in)	N/A	N/A	DWS Contrast?	N/A
N/A	Landing Slope (%)	N/A	N/A	DWS Length (in)	N/A
N/A	Landing X Slope (%)	N/A	N/A	DWS Full Width?	N/A
N/A	Landing Curb? (Y/N)	N/A	N/A	DWS Offset (in)	N/A
N/A	Shared Landing?	N/A			
N/A	Gutter Ponding?	N/A	N/A	Gutter Slope (%)	N/A
N/A	Gutter Lip Ht (in)	N/A	N/A	Gutter X Slope (%)	N/A
N/A	Painted X Walk1?	No	N/A	Painted X Walk2?	N/A
	X Walk 1 Direction	To SW		X Walk 2 Direction	N/A
N/A	X Walk 1 Width (in)	N/A	N/A	X Walk 2 Width (in)	N/A
	X Walk 1 Slope (%)	2.5		X Walk 2 Slope (%)	N/A
	X Walk 1 X Slope (%)	1.2		X Walk 2 X Slope (%)	N/A

N/A	Ramp inside XWalk1?	N/A	N/A	Ramp inside XWalk2?	N/A
	Road Slope (%)	N/A	N/A	Clear Space?	N/A
	Road X Slope (%)	N/A	N/A	Clear Space to XWalk (in)	N/A
N/A	Any Obstructions?	N/A	N/A	Storm Grate/Utility Hazard?	N/A
	Obstruction Type			Storm Grate/Utility Type	
		N/A			N/A
			Yes	Surface Condition? (G/P)	Good

Possible Solutions:

Remove & Replace Entire Ramp.
