Access Compliance Report

Public Rights-of-Way

(Curb Ramps)

Intersection ID: 8474	Main Street: ASBURY_AV	Cross Street: UPPER_ASBURY_AV	Location: W
ADA ID: D8D2A13A3BE2	Ramp Type: Perp	Initial Pass/Fail: Fail	Overall Compliance: No
Severity Score: 21.25			
Codes/Mitigation Info/Possible Solution		Field Measurements/Component Compliance

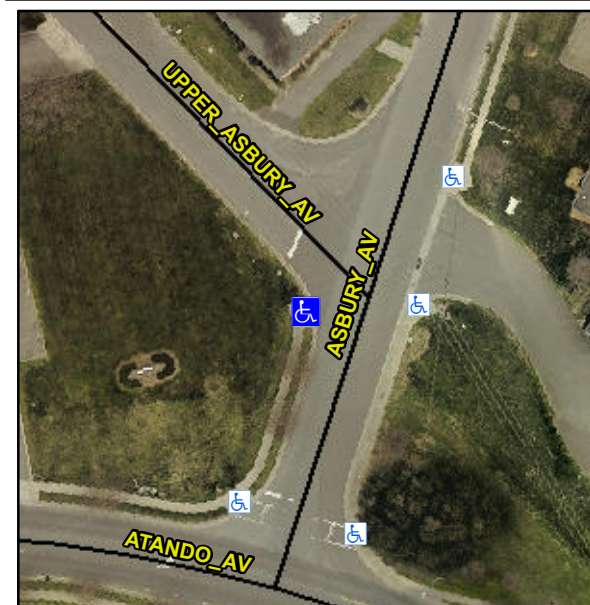
Not Found, R304.5.1, R304.2.2

Compliance	Description	Data	Compliance	Description	Data
N/A	Ramp Length (in)	60.0	No	Ramp Slope (%)	10.3
No	Ramp Width (in)	44.0	Yes	Ramp XSlope (%)	1.9
N/A	Flare Type LT	N/A	N/A	Flare Type RT	N/A
N/A	Flare Slope LT (%)	N/A	N/A	Flare Slope RT (%)	N/A
N/A	Flare Traversable LT?	N/A	N/A	Flare Traversable RT?	N/A
N/A	Landing Length (in)	N/A	N/A	DWS Provided?	N/A
N/A	Landing Width (in)	N/A	N/A	DWS Contrast?	N/A
N/A	Landing Slope (%)	N/A	N/A	DWS Length (in)	N/A
N/A	Landing X Slope (%)	N/A	N/A	DWS Full Width?	N/A
N/A	Landing Curb? (Y/N)	N/A	N/A	DWS Offset (in)	N/A
N/A	Shared Landing?	N/A			
N/A	Gutter Ponding?	N/A	N/A	Gutter Slope (%)	N/A
N/A	Gutter Lip Ht (in)	N/A	N/A	Gutter X Slope (%)	N/A
N/A	Painted X Walk1?	No	N/A	Painted X Walk2?	N/A
	X Walk 1 Direction	To E		X Walk 2 Direction	N/A
N/A	X Walk 1 Width (in)	N/A	N/A	X Walk 2 Width (in)	N/A
	X Walk 1 Slope (%)	3.3		X Walk 2 Slope (%)	N/A
	X Walk 1 X Slope (%)	2.2		X Walk 2 X Slope (%)	N/A

N/A	Ramp inside XWalk1?	N/A	N/A	Ramp inside XWalk2?	N/A
	Road Slope (%)	N/A	N/A	Clear Space?	N/A
	Road X Slope (%)	N/A	N/A	Clear Space to XWalk (in)	N/A
N/A	Any Obstructions?	N/A	N/A	Storm Grate/Utility Hazard?	N/A
	Obstruction Type			Storm Grate/Utility Type	
		N/A			N/A
			Yes	Surface Condition? (G/P)	Good

Possible Solutions:

Remove & Replace Entire Ramp.

Total Cost: \$ 1850.00
