# Access Compliance Report

## Public Rights-of-Way

### (Curb Ramps)

Intersection ID: 5553	Main Street: HAWKINS_PL	Cross Street: ROCKWELL_BV	Location: E
ADA ID: D8D4416D689C	Ramp Type: Para	Initial Pass/Fail: Fail	Overall Compliance: No
Codes/Mitigation Info/Possible Solution		Field Measurements/Component Compliance

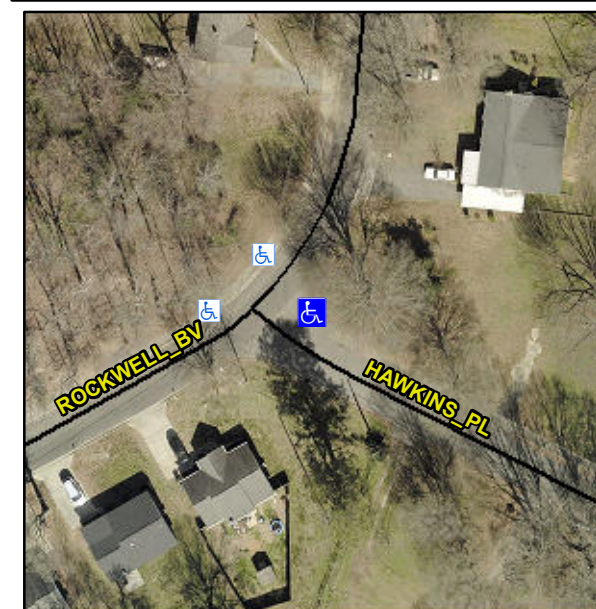
Compliance	Description	Data	Compliance	Description	Data
N/A	Ramp Length LT (in)	51.0	N/A	Ramp Length RT (in)	57.0
No	Ramp Width LT (in)	37.5	No	Ramp Width RT (in)	36.0
No	Ramp Slope LT (%)	9.5	Yes	Ramp Slope RT (%)	5.1
Yes	Ramp XSlope LT (%)	2.0	Yes	Ramp XSlope RT (%)	1.9
N/A	Landing Length (in)	N/A	N/A	DWS Provided?	N/A
N/A	Landing Width (in)	N/A	N/A	DWS Contrast?	N/A
N/A	Landing Slope (%)	N/A	N/A	DWS Length (in)	N/A
N/A	Landing X Slope (%)	N/A	N/A	DWS Full Width?	N/A
N/A	Landing Curb? (Y/N)	N/A	N/A	DWS Offset (in)	N/A
N/A	Shared Landing?	N/A			
N/A	Gutter Ponding?	N/A	N/A	Gutter Slope (%)	N/A
N/A	Gutter Lip Ht (in)	N/A	N/A	Gutter X Slope (%)	N/A
N/A	Painted X Walk1?	No	N/A	Painted X Walk2?	N/A
	X Walk 1 Direction	To W		X Walk 2 Direction	N/A
N/A	X Walk 1 Width (in)	N/A	N/A	X Walk 2 Width (in)	N/A
	X Walk 1 Slope (%)	0.7		X Walk 2 Slope (%)	N/A
	X Walk 1 X Slope (%)	4.4		X Walk 2 X Slope (%)	N/A
N/A	Ramp inside XWalk1?	N/A	N/A	Ramp inside XWalk2?	N/A

Road Slope (%)	N/A	N/A	Clear Space?	N/A
	Road X Slope (%)	N/A	N/A	Clear Space to XWalk (in)	N/A
N/A	Any Obstructions?	N/A	N/A	Storm Grate/Utility Hazard?	N/A
	Obstruction Type			Storm Grate/Utility Type	
		N/A			N/A
			Yes	Surface Condition? (G/P)	Good
			N/A	Curb Slope (%)	16.5

Possible Solutions:

**Remove & Replace Entire Ramp.**

**R304.5.1, R304.3.2**
