# Access Compliance Report

## Public Rights-of-Way

### (Curb Ramps)

| Intersection ID: 19888 | Main Street: SHIRAS_CT | Cross Street: THORNFIELD_RD | Location: SE |

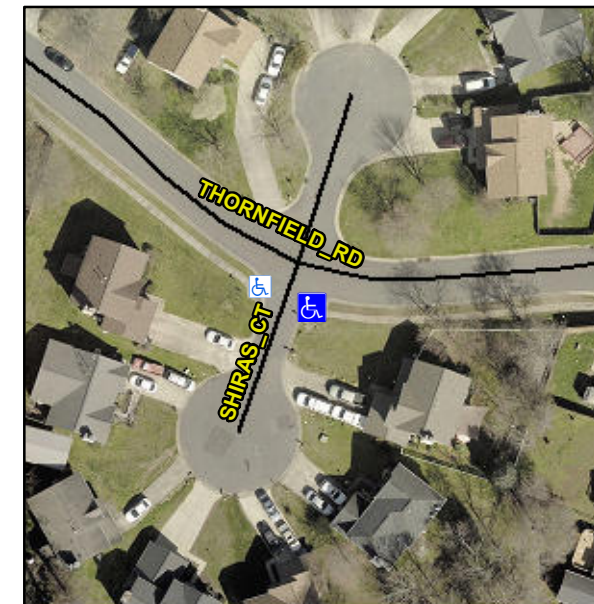
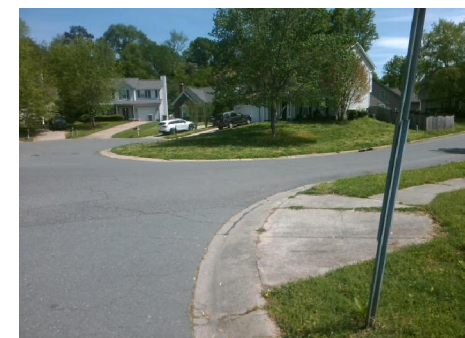
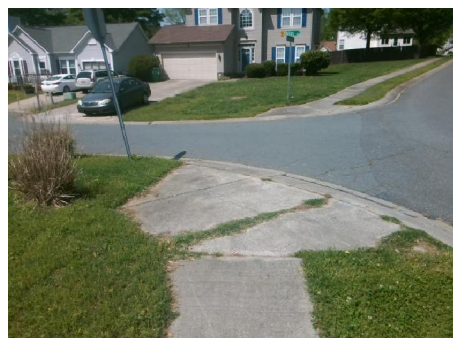
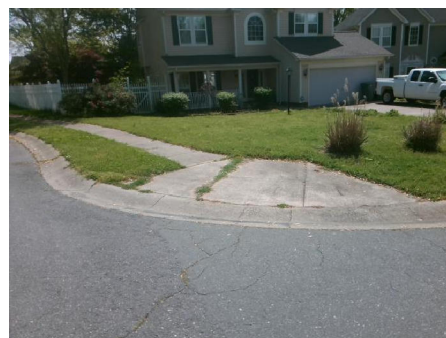
| ADA ID: D8D4A9B4D040 | Ramp Type: BlendTrans1 | Initial Pass/Fail: Pass | Overall Compliance: No |
| Severity Score: 17.75 | | | |

**Not Found, R304.5.3, R305, R302.7.2**

| Compliance | Description | Data | Compliance | Description | Data |
|---|---|---|---|---|---|
| Yes | Ramp Width (in) | 89.0 | No | BlendTrans XSlope (%) | 3.9 |
| Yes | Landing Length (in) | 51.0 | No | DWS Provided? | No |
| No | Landing X Slope (%) | 3.8 | N/A | DWS Full Width? | No |
| No | Gutter Lip Ht (in) | 0.5 | Yes | Gutter X Slope (%) | 1.5 |

**Remove & Replace Curb Ramp With Two New Directional Ramps or Equivalent.**
