Access Compliance Report

Public Rights-of-Way

(Curb Ramps)

Intersection ID: 50539	Main Street: CAYENNE_DR	Cross Street: MT_HOLLY-HUNTERSVILLE_RD	Location: SW
ADA ID: D8DD7A27B989	Ramp Type: Perp	Initial Pass/Fail: Fail	Overall Compliance: No
Severity Score: 33.75			
Codes/Mitigation Info/Possible Solution		Field Measurements/Component Compliance

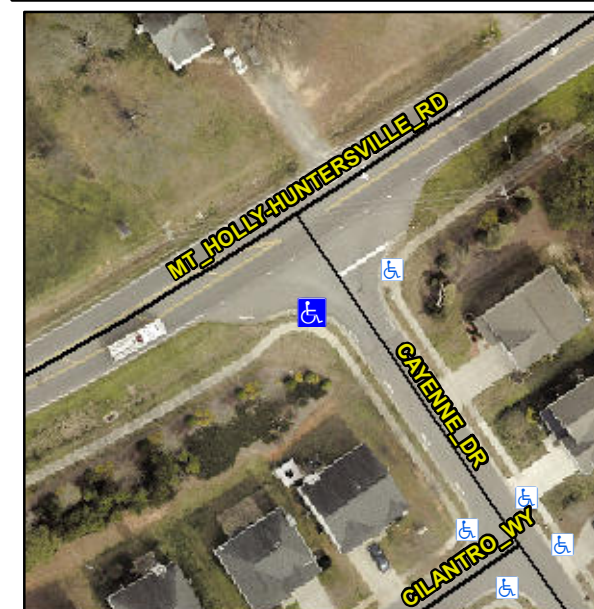
Not Found, R304.5.1, R304.5.3

Compliance	Description	Data	Compliance	Description	Data
N/A	Ramp Length (in)	48.5	Yes	Ramp Slope (%)	5.9
No	Ramp Width (in)	46.0	No	Ramp XSlope (%)	8.4
N/A	Flare Type LT	N/A	N/A	Flare Type RT	N/A
N/A	Flare Slope LT (%)	N/A	N/A	Flare Slope RT (%)	N/A
N/A	Flare Traversable LT?	N/A	N/A	Flare Traversable RT?	N/A
N/A	Landing Length (in)	N/A	N/A	DWS Provided?	N/A
N/A	Landing Width (in)	N/A	N/A	DWS Contrast?	N/A
N/A	Landing Slope (%)	N/A	N/A	DWS Length (in)	N/A
N/A	Landing X Slope (%)	N/A	N/A	DWS Full Width?	N/A
N/A	Landing Curb? (Y/N)	N/A	N/A	DWS Offset (in)	N/A
N/A	Shared Landing?	N/A			
N/A	Gutter Ponding?	N/A	N/A	Gutter Slope (%)	N/A
N/A	Gutter Lip Ht (in)	N/A	N/A	Gutter X Slope (%)	N/A
N/A	Painted X Walk1?	No	N/A	Painted X Walk2?	N/A
	X Walk 1 Direction	To E		X Walk 2 Direction	N/A
N/A	X Walk 1 Width (in)	N/A	N/A	X Walk 2 Width (in)	N/A
	X Walk 1 Slope (%)	3.5		X Walk 2 Slope (%)	N/A
	X Walk 1 X Slope (%)	5.5		X Walk 2 X Slope (%)	N/A

Possible Solutions:

Remove & Replace Entire Ramp.

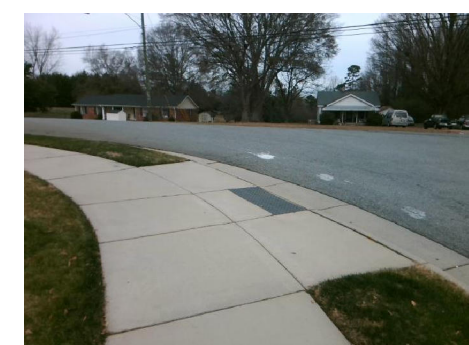
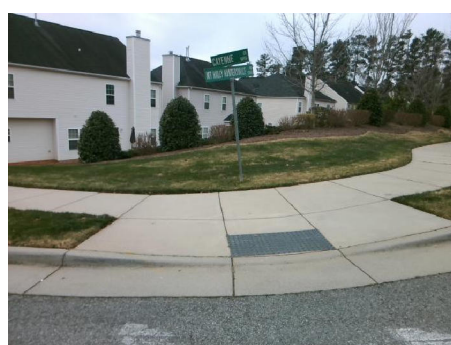
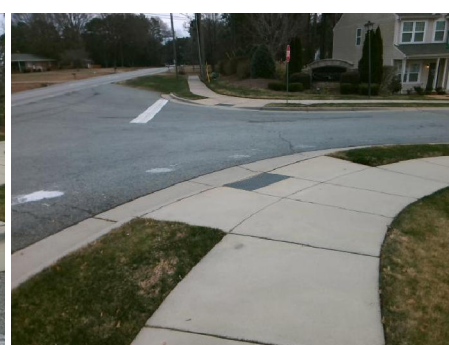
N/A	Ramp inside XWalk1?	N/A	N/A	Ramp inside XWalk2?	N/A
	Road Slope (%)	N/A	N/A	Clear Space?	N/A
	Road X Slope (%)	N/A	N/A	Clear Space to XWalk (in)	N/A
N/A	Any Obstructions?	N/A	N/A	Storm Grate/Utility Hazard?	N/A
	Obstruction Type			Storm Grate/Utility Type	
		N/A			N/A
			Yes	Surface Condition? (G/P)	Good
