Access Compliance Report

Public Rights-of-Way

(Curb Ramps)

Intersection ID: 10032967	Main Street: NEWBURY GROVE ST	Cross Street: N/A	Location: NE
ADA ID: D8DEFD6F0116	Ramp Type: Perp	Initial Pass/Fail: Fail	Overall Compliance: No
Severity Score: 8.75			
Codes/Mitigation Info/Possible Solution		Field Measurements/Component Compliance

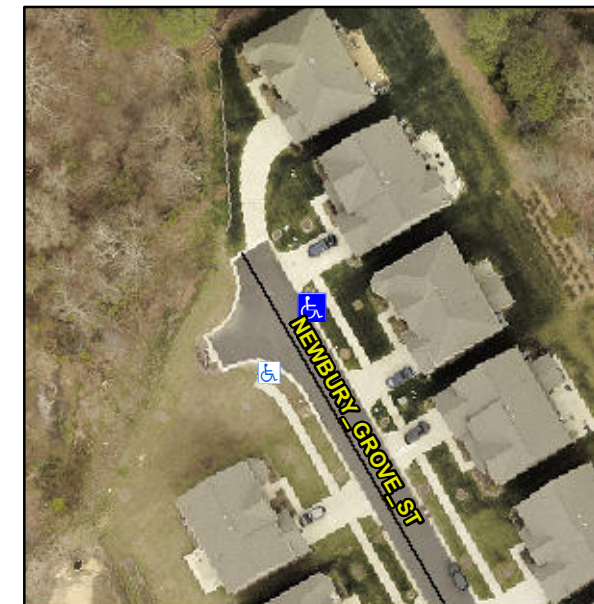
Not Found, R304.5.1

Compliance	Description	Data	Compliance	Description	Data
N/A	Ramp Length (in)	94.0	Yes	Ramp Slope (%)	5.3
No	Ramp Width (in)	47.0	Yes	Ramp XSlope (%)	0.2
N/A	Flare Type LT	N/A	N/A	Flare Type RT	N/A
N/A	Flare Slope LT (%)	N/A	N/A	Flare Slope RT (%)	N/A
N/A	Flare Traversable LT?	N/A	N/A	Flare Traversable RT?	N/A
N/A	Landing Length (in)	N/A	N/A	DWS Provided?	N/A
N/A	Landing Width (in)	N/A	N/A	DWS Contrast?	N/A
N/A	Landing Slope (%)	N/A	N/A	DWS Length (in)	N/A
N/A	Landing X Slope (%)	N/A	N/A	DWS Full Width?	N/A
N/A	Landing Curb? (Y/N)	N/A	N/A	DWS Offset (in)	N/A
N/A	Shared Landing?	N/A			
N/A	Gutter Ponding?	N/A	N/A	Gutter Slope (%)	N/A
N/A	Gutter Lip Ht (in)	N/A	N/A	Gutter X Slope (%)	N/A
N/A	Painted X Walk1?	No	N/A	Painted X Walk2?	N/A
	X Walk 1 Direction	To SW		X Walk 2 Direction	N/A
N/A	X Walk 1 Width (in)	N/A	N/A	X Walk 2 Width (in)	N/A
	X Walk 1 Slope (%)	1.5		X Walk 2 Slope (%)	N/A
	X Walk 1 X Slope (%)	2.7		X Walk 2 X Slope (%)	N/A

N/A	Ramp inside XWalk1?	N/A	N/A	Ramp inside XWalk2?	N/A
	Road Slope (%)	N/A	N/A	Clear Space?	N/A
	Road X Slope (%)	N/A	N/A	Clear Space to XWalk (in)	N/A
N/A	Any Obstructions?	N/A	N/A	Storm Grate/Utility Hazard?	N/A
	Obstruction Type			Storm Grate/Utility Type	
		N/A			N/A
			Yes	Surface Condition? (G/P)	Good

Possible Solutions:

Remove & Replace Entire Ramp.
