Access Compliance Report

Public Rights-of-Way

(Curb Ramps)

Intersection ID: 11163	Main Street: EVERETT_PL	Cross Street: UNION_ST	Location: SW
ADA ID: D8E1EA5ED628	Ramp Type: Perp	Initial Pass/Fail: Fail	Overall Compliance: No
		Severity Score: 22.5

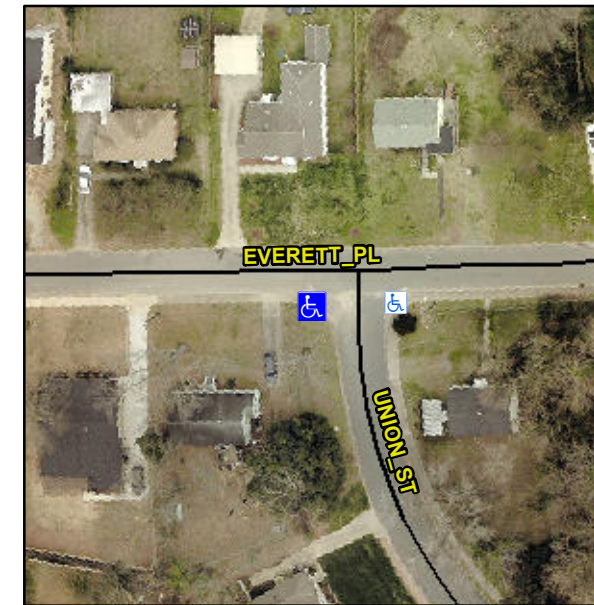
Not Found, R304.5.1, R304.2.2, R304.5.3

Compliance	Description	Data	Compliance	Description	Data
N/A	Ramp Length (in)	51.5	No	Ramp Slope (%)	9.7
No	Ramp Width (in)	39.5	No	Ramp XSlope (%)	4.5
N/A	Flare Type LT	N/A	N/A	Flare Type RT	N/A
N/A	Flare Slope LT (%)	N/A	N/A	Flare Slope RT (%)	N/A
N/A	Flare Traversable LT?	N/A	N/A	Flare Traversable RT?	N/A
N/A	Landing Length (in)	N/A	N/A	DWS Provided?	N/A
N/A	Landing Width (in)	N/A	N/A	DWS Contrast?	N/A
N/A	Landing Slope (%)	N/A	N/A	DWS Length (in)	N/A
N/A	Landing X Slope (%)	N/A	N/A	DWS Full Width?	N/A
N/A	Landing Curb? (Y/N)	N/A	N/A	DWS Offset (in)	N/A
N/A	Shared Landing?	N/A			
N/A	Gutter Ponding?	N/A	N/A	Gutter Slope (%)	N/A
N/A	Gutter Lip Ht (in)	N/A	N/A	Gutter X Slope (%)	N/A
N/A	Painted X Walk1?	No	N/A	Painted X Walk2?	N/A
	X Walk 1 Direction	To E		X Walk 2 Direction	N/A
N/A	X Walk 1 Width (in)	N/A	N/A	X Walk 2 Width (in)	N/A
	X Walk 1 Slope (%)	1.1		X Walk 2 Slope (%)	N/A
	X Walk 1 X Slope (%)	0.3		X Walk 2 X Slope (%)	N/A

N/A	Ramp inside XWalk1?	N/A	N/A	Ramp inside XWalk2?	N/A
	Road Slope (%)	N/A	N/A	Clear Space?	N/A
	Road X Slope (%)	N/A	N/A	Clear Space to XWalk (in)	N/A
N/A	Any Obstructions?	N/A	N/A	Storm Grate/Utility Hazard?	N/A
	Obstruction Type			Storm Grate/Utility Type	
		N/A			N/A
			Yes	Surface Condition? (G/P)	Good

Remove & Replace Entire Ramp.
