# Access Compliance Report

## Public Rights-of-Way

### (Curb Ramps)

| Intersection ID: 11357 | Main Street: W_TRADE_ST | Cross Street: N_IRWIN_AV | Location: N |

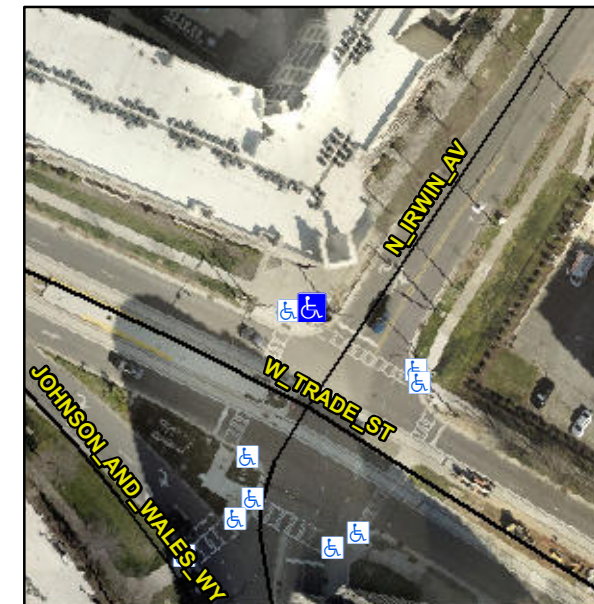
**N/A**

**R304.5.3, R304.2.3, R305.2, R304.5.4**

| Compliance | Description | Data | Compliance | Description | Data |
|---|---|---|---|---|---|
| Yes | Ramp Width (in) | 57.0 | No | Ramp XSlope (%) | 4.9 |
| No | Flare Type | Curbed_WithWalkSurface | Yes | Flare Type RT | N/A |
| No | Landing X Slope (%) | 3.2 | Yes | DWS Full Width? | Yes |
| N/A | Landing Curb? (Y/N) | No | No | DWS Offset (in) | 5.0 |
| Yes | Gutter Ponding? | No | No | Gutter Slope (%) | 6.6 |
| Yes | Gutter Lip Ht (in) | 0.0 | No | Gutter X Slope (%) | 3.8 |

**Remove & Replace Entire Ramp.  
Remove & Replace Gutter.**

Total Cost: \$ 2600.00
