Access Compliance Report

Public Rights-of-Way

(Curb Ramps)

Intersection ID: 20061	Main Street: S_TRYON_ST	Cross Street: YORKHILLS_DR	Location: NE
ADA ID: D903E54D3C87	Ramp Type: PerpDiag	Initial Pass/Fail: Pass	Overall Compliance: No
		Severity Score: 20

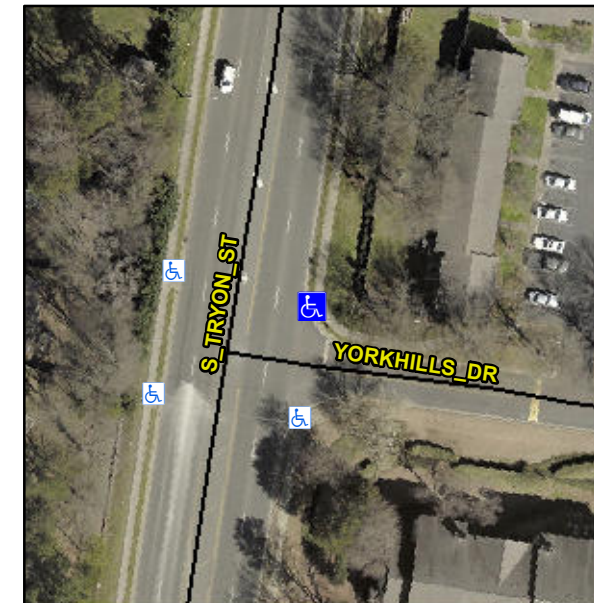
Compliance	Description	Data	Compliance	Description	Data
N/A	Ramp Length (in)	89.0	Yes	Ramp Slope (%)	7.4
Yes	Ramp Width (in)	54.0	Yes	Ramp XSlope (%)	1.2
N/A	Flare Type LT	Sloped	N/A	Flare Type RT	N/A
N/A	Flare Slope LT (%)	9.4	Yes	Flare Slope RT (%)	5.1
N/A	Flare Traversable LT?	Yes	N/A	Flare Traversable RT?	Yes
No	Landing Length (in)	N/A	No	DWS Provided?	No
No	Landing Width (in)	N/A	N/A	DWS Contrast?	No
No	Landing Slope (%)	N/A	N/A	DWS Length (in)	N/A
No	Landing X Slope (%)	N/A	N/A	DWS Full Width?	No
N/A	Landing Curb? (Y/N)	No	N/A	DWS Offset (in)	N/A
N/A	Shared Landing?	No			
Yes	Gutter Ponding?	No	Yes	Gutter Slope (%)	4.1
Yes	Gutter Lip Ht (in)	0.0	Yes	Gutter X Slope (%)	0.8
N/A	Painted X Walk1?	No	N/A	Painted X Walk2?	No
	X Walk 1 Direction	To W		X Walk 2 Direction	To S
N/A	X Walk 1 Width (in)	N/A	N/A	X Walk 2 Width (in)	N/A
	X Walk 1 Slope (%)	2.0		X Walk 2 Slope (%)	2.1
	X Walk 1 X Slope (%)	2.4		X Walk 2 X Slope (%)	3.1

N/A	Ramp inside XWalk1?	N/A	N/A	Ramp inside XWalk2?	N/A
	Road Slope (%)	1.5	N/A	Clear Space?	Yes
	Road X Slope (%)	4.0	N/A	Clear Space to XWalk (in)	N/A
Yes	Any Obstructions?	No	Yes	Storm Grate/Utility Hazard?	No
	Obstruction Type			Storm Grate/Utility Type	
		N/A			N/A
			Yes	Surface Condition? (G/P)	Good

Possible Solutions:

Remove & Replace Curb Ramp With Two New Directional Ramps or Equivalent.

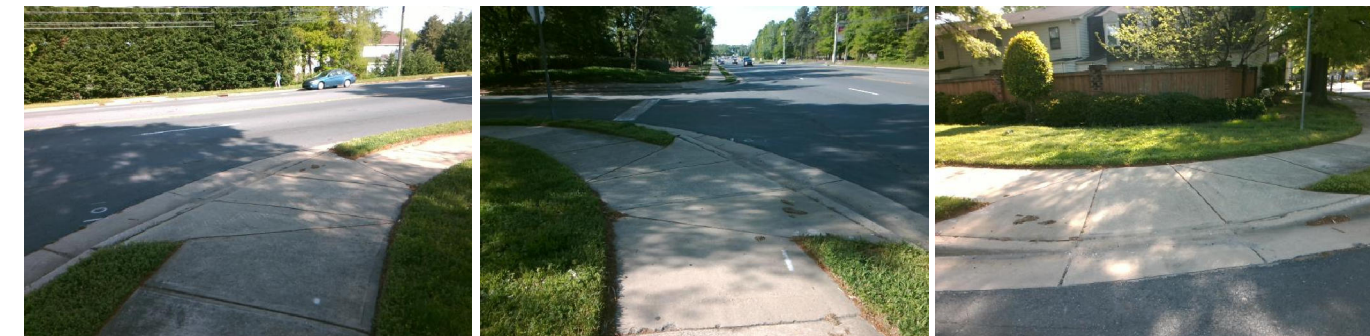
Street 1 Name S TRYON ST
 Stop Condition-Street 2 None
 Street 2 Name YORKHILLS DR
 Stop Condition-Street 1 StopSign
