## Access Compliance Report Public Rights-of-Way (Curb Ramps)

Intersection ID: 31171 Main Street: POINTER\_RD Cross Street: BROWNE\_RD Location: SE

ADA ID: D90BE2AF02C0 Ramp Type: Para Initial Pass/Fail: Fail Overall Compliance: No Severity Score: 26.25

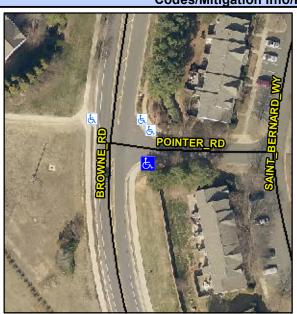
LT RP < 5%

Field Measurements/Component Compilance					
Compliance Description		Data	Comp	liance Description	Data
N/A	Ramp Length LT (in)	68.0	N/A	Ramp Length RT (in)	46.0
Yes	Ramp Width LT (in)	71.0	Yes	Ramp Width RT (in)	70.0
Yes	Ramp Slope LT (%)	2.9	No	Ramp Slope RT (%)	12.4
No	Ramp XSlope LT (%)	2.3	No	Ramp XSlope RT (%)	3.8
N/A	Landing Length (in)	N/A	N/A	DWS Provided?	N/A
N/A	Landing Width (in)	N/A	N/A	DWS Contrast?	N/A
N/A	Landing Slope (%)	N/A	N/A	DWS Length (in)	N/A
N/A	Landing X Slope (%)	N/A	N/A	DWS Full Width?	N/A
N/A	Landing Curb? (Y/N)	N/A	N/A	DWS Offset (in)	N/A
N/A	Shared Landing?	N/A			
N/A	Gutter Ponding?	N/A	N/A	Gutter Slope (%)	N/A
N/A	Gutter Lip Ht (in)	N/A	N/A	Gutter X Slope (%)	N/A
N/A	Painted X Walk1?	No	N/A	Painted X Walk2?	N/A
	X Walk 1 Direction	To N		X Walk 2 Direction	N/A
N/A	X Walk 1 Width (in)	N/A	N/A	X Walk 2 Width (in)	N/A
	X Walk 1 Slope (%)	1.2		X Walk 2 Slope (%)	N/A
	X Walk 1 X Slope (%)	4.4		X Walk 2 X Slope (%)	N/A

Remove & Replace Entire Ramp.

R304.5.3, R304.3.2
