Access Compliance Report

Public Rights-of-Way

(Curb Ramps)

Intersection ID: 10034710	Main Street: POINDEXTER_DR	Cross Street: N/A	Location:	N
ADA ID: D91B0F76F79D	Ramp Type: Perp	Initial Pass/Fail: Fail	Overall Compliance: No	Severity Score: 12.5

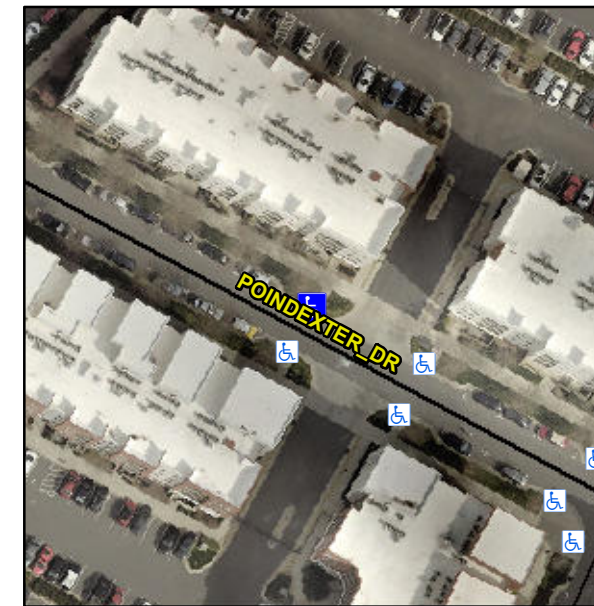
Not Found, R304.2.2

Compliance	Description	Data	Compliance	Description	Data
N/A	Ramp Length (in)	72.0	No	Ramp Slope (%)	8.6
Yes	Ramp Width (in)	57.0	Yes	Ramp XSlope (%)	0.5
N/A	Flare Type LT	N/A	N/A	Flare Type RT	N/A
N/A	Flare Slope LT (%)	N/A	N/A	Flare Slope RT (%)	N/A
N/A	Flare Traversable LT?	N/A	N/A	Flare Traversable RT?	N/A
N/A	Landing Length (in)	N/A	N/A	DWS Provided?	N/A
N/A	Landing Width (in)	N/A	N/A	DWS Contrast?	N/A
N/A	Landing Slope (%)	N/A	N/A	DWS Length (in)	N/A
N/A	Landing X Slope (%)	N/A	N/A	DWS Full Width?	N/A
N/A	Landing Curb? (Y/N)	N/A	N/A	DWS Offset (in)	N/A
N/A	Shared Landing?	N/A			
N/A	Gutter Ponding?	N/A	N/A	Gutter Slope (%)	N/A
N/A	Gutter Lip Ht (in)	N/A	N/A	Gutter X Slope (%)	N/A
N/A	Painted X Walk1?	No	N/A	Painted X Walk2?	N/A
	X Walk 1 Direction	To SW		X Walk 2 Direction	N/A
N/A	X Walk 1 Width (in)	N/A	N/A	X Walk 2 Width (in)	N/A
	X Walk 1 Slope (%)	1.1		X Walk 2 Slope (%)	N/A
	X Walk 1 X Slope (%)	2.3		X Walk 2 X Slope (%)	N/A

N/A	Ramp inside XWalk1?	N/A	N/A	Ramp inside XWalk2?	N/A
	Road Slope (%)	N/A	N/A	Clear Space?	N/A
	Road X Slope (%)	N/A	N/A	Clear Space to XWalk (in)	N/A
N/A	Any Obstructions?	N/A	N/A	Storm Grate/Utility Hazard?	N/A
	Obstruction Type			Storm Grate/Utility Type	
		N/A			N/A
			Yes	Surface Condition? (G/P)	Good

Remove & Replace Entire Ramp.
