Access Compliance Report Public Rights-of-Way (Curb Ramps)

Intersection ID: 30291 Main Street: BLYTHEDALE DR **Cross Street: GALLATIN LN** Location: NE ADA ID: D929B0B65F5C Ramp Type: PerpDiag Initial Pass/Fail: Pass **Overall Compliance: No Severity Score:** 10

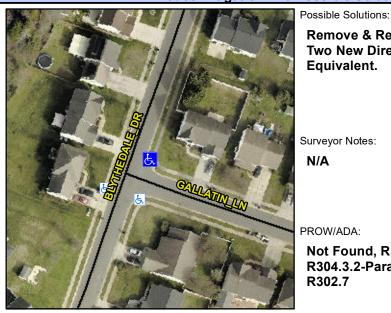
Comp	liance Description	Data	Comp	oliance Description	Data
N/A	Ramp Length (in)	44.0	Yes	Ramp Slope (%)	5.7
Yes	Ramp Width (in)	62.0	Yes	Ramp XSlope (%)	0.2
N/A	Flare Type LT	Sloped	N/A	Flare Type RT	N/A
N/A	Flare Slope LT (%)	7.2	N/A	Flare Slope RT (%)	4.4
N/A	Flare Traversable LT?	No	N/A	Flare Traversable RT?	No
Yes	Landing Length (in)	49.0	No	DWS Provided?	No
No	Landing Width (in)	40.0	N/A	DWS Contrast?	No
No	Landing Slope (%)	3.9	N/A	DWS Length (in)	N/A
No	Landing X Slope (%)	3.0	N/A	DWS Full Width?	No
N/A	Landing Curb? (Y/N)	No	N/A	DWS Offset (in)	N/A
N/A	Shared Landing?	No			
No	Gutter Ponding?	Yes	Yes	Gutter Slope (%)	1.5
Yes	Gutter Lip Ht (in)	0.0	Yes	Gutter X Slope (%)	0.4
N/A	Painted X Walk1?	No	N/A	Painted X Walk2?	No
	X Walk 1 Direction	To W		X Walk 2 Direction	To S
N/A	X Walk 1 Width (in)	N/A	N/A	X Walk 2 Width (in)	N/A
	X Walk 1 Slope (%)	5.0		X Walk 2 Slope (%)	0.9
	X Walk 1 X Slope (%)	1.5		X Walk 2 X Slope (%)	1.5

N/A	Ramp inside XWalk1?	N/A	N/A	Ramp inside XWalk2?	N/A
	Road Slope (%)	1.2	N/A	Clear Space?	Yes
	Road X Slope (%)	3.2	N/A	Clear Space to XWalk (in)	N/A
Yes	Any Obstructions?	No	Yes	Storm Grate/Utility Hazard?	No No
	Obstruction Type			Storm Grate/Utility Type	
		N/A			N/A
			Yes	Surface Condition? (G/P)	Good

Street 1 Name Stop Condition-Street 2 Street 2 Name Stop Condition-Street 1 **BLYTHEDALE DR** None **GALLATIN LN** StopSign Remove & Replace Curb Ramp With Two New Directional Ramps or Equivalent.

Not Found, R304.2.1, R304.2.2-Perp, R304.3.2-Para, R304.5.3, R305, R302.7

Total Cost: 3200.00
