Access Compliance Report

Public Rights-of-Way

(Curb Ramps)

Intersection ID: N/A	Main Street: SOUTH_BV	Cross Street: N/A	Location: NW
ADA ID: D92A5B81E086	Ramp Type: Directional1	Initial Pass/Fail: Fail	Overall Compliance: No
			Severity Score: 13.75

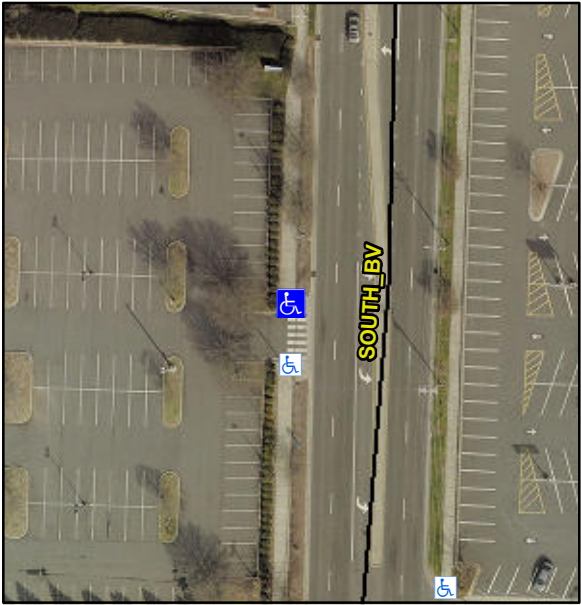
Possible Solutions:		Compliance	Description	Data	
	Remove & Replace Entire Ramp.		N/A	Ramp Length (in)	124.0	N/A
			Yes	Ramp Width (in)	96.0	N/A
			No	Ramp Slope (%)	10.7	N/A
			No	Ramp XSlope (%)	3.0	N/A
			N/A	Flare Type LT	N/A	N/A
			N/A	Flare Slope LT (%)	N/A	N/A
			N/A	Flare Traversable LT?	N/A	N/A
			N/A	Landing Length (in)	0.0	N/A
			N/A	Landing Width (in)	0.0	N/A
			N/A	Landing Slope (%)	0.0	N/A
			N/A	Landing X Slope (%)	0.0	N/A
			N/A	Landing Curb? (Y/N)	N/A	N/A
			N/A	Shared Landing?	N/A	N/A
			N/A	Gutter Ponding?	0.0	N/A
			N/A	Gutter Lip Ht (in)	0.0	N/A
			N/A	Painted X Walk1?	Yes	N/A
				X Walk 1 Direction	To S	N/A
				X Walk 1 Width (in)	120.5	N/A
				X Walk 1 Slope (%)	1.0	N/A
<p>Surveyor Notes:</p> <p>N/A</p> <p>PROW/ADA:</p> <p>R304.2.2, R304.5.3</p>						
			N/A	X Walk 1 X Slope (%)	0.5	N/A
			N/A	Ramp inside XWalk1?	Yes	N/A

N/A	Any Obstructions?	N/A	N/A
				Obstruction Type		N/A
			Yes	Surface Condition? (G/P)		Good
			N/A	Curb Slope (%)		6.9
Street 1 Name	ENTRANCE					
Stop Condition-Street 1	None					
Street 2 Name	N/A					
Stop Condition-Street 2	N/A					
Total Cost:	\$	1600.00
