# Access Compliance Report

## Public Rights-of-Way

### (Curb Ramps)

Intersection ID: 6945	Main Street: MCALLISTER_DR	Cross Street: RICH_LN	Location:	NW
ADA ID: D92EB7BFD7A2	Ramp Type: PerpDiag	Initial Pass/Fail: Fail	Overall Compliance: No	Severity Score: 22.5

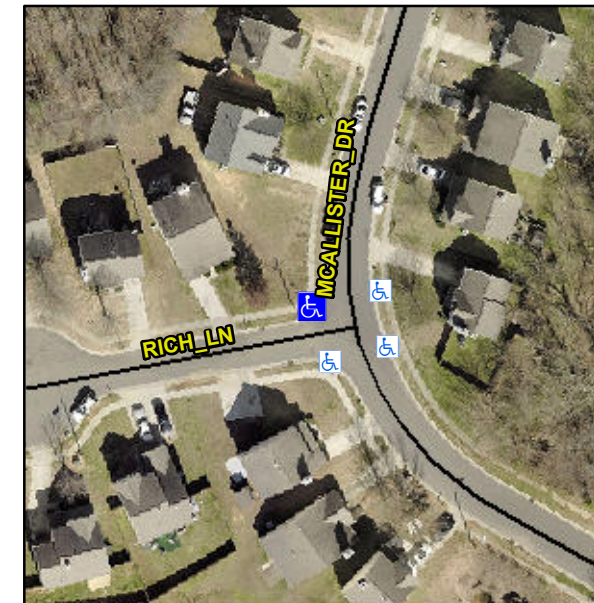
Compliance	Description	Data	Compliance	Description	Data
N/A	Ramp Length (in)	47.0	No	Ramp Slope (%)	8.7
No	Ramp Width (in)	36.0	No	Ramp XSlope (%)	4.7
N/A	Flare Type LT	N/A	N/A	Flare Type RT	N/A
N/A	Flare Slope LT (%)	N/A	N/A	Flare Slope RT (%)	N/A
N/A	Flare Traversable LT?	N/A	N/A	Flare Traversable RT?	N/A
N/A	Landing Length (in)	N/A	N/A	DWS Provided?	N/A
N/A	Landing Width (in)	N/A	N/A	DWS Contrast?	N/A
N/A	Landing Slope (%)	N/A	N/A	DWS Length (in)	N/A
N/A	Landing X Slope (%)	N/A	N/A	DWS Full Width?	N/A
N/A	Landing Curb? (Y/N)	N/A	N/A	DWS Offset (in)	N/A
N/A	Shared Landing?	N/A			
N/A	Gutter Ponding?	N/A	N/A	Gutter Slope (%)	N/A
N/A	Gutter Lip Ht (in)	N/A	N/A	Gutter X Slope (%)	N/A
N/A	Painted X Walk1?	No	N/A	Painted X Walk2?	No
	X Walk 1 Direction	To S		X Walk 2 Direction	To E
N/A	X Walk 1 Width (in)	N/A	N/A	X Walk 2 Width (in)	N/A
	X Walk 1 Slope (%)	3.4		X Walk 2 Slope (%)	2.2
	X Walk 1 X Slope (%)	3.5		X Walk 2 X Slope (%)	4.2

N/A	Ramp inside XWalk1?	N/A	N/A	Ramp inside XWalk2?	N/A
	Road Slope (%)	5.0	N/A	Clear Space?	N/A
	Road X Slope (%)	0.3	N/A	Clear Space to XWalk (in)	N/A
N/A	Any Obstructions?	N/A	N/A	Storm Grate/Utility Hazard?	N/A
	Obstruction Type			Storm Grate/Utility Type	
		N/A			N/A
			Yes	Surface Condition? (G/P)	Good

**Remove & Replace Curb Ramp With Two New Directional Ramps or Equivalent.**

**R304.5.1, R304.2.2, R304.5.3**
